# Georges River Estuary NEAP Bank Erosion and Riparian Condition Assessment Report

3 July 2025

Description: **Georges River Estuary – NEAP Bank Erosion and Riparian Vegetation Condition Assessment Report.**

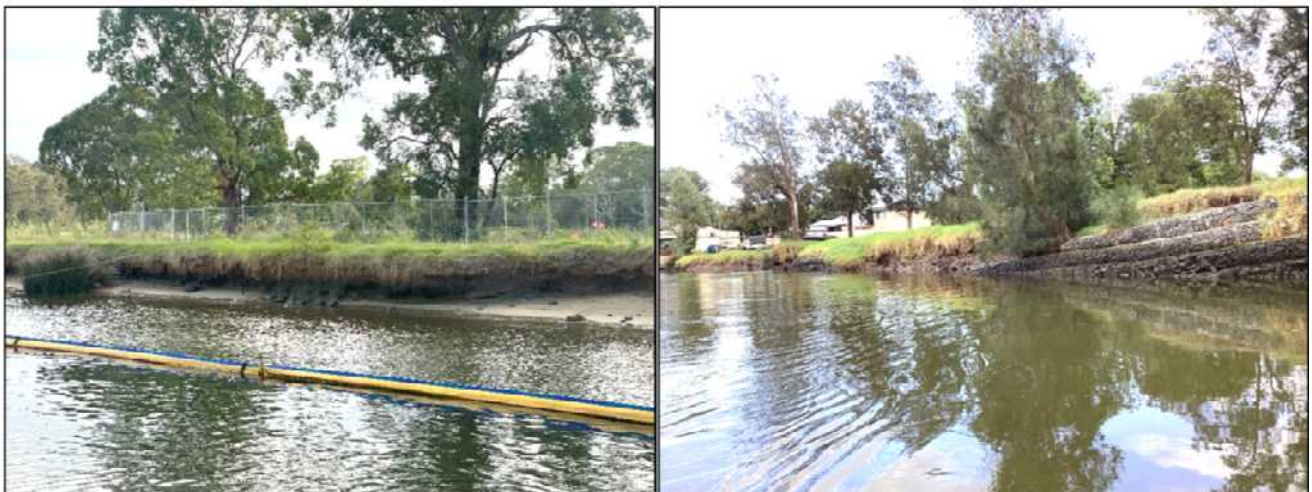
*Plate 1 From left to right: boat wave wash erosion is common in the Fluvial Dominated process zone particularly around Milpera (upper Georges River Reach 250); bank toe scour and slumping and typical processes occurring in the Fluvial Dominated process zone.*

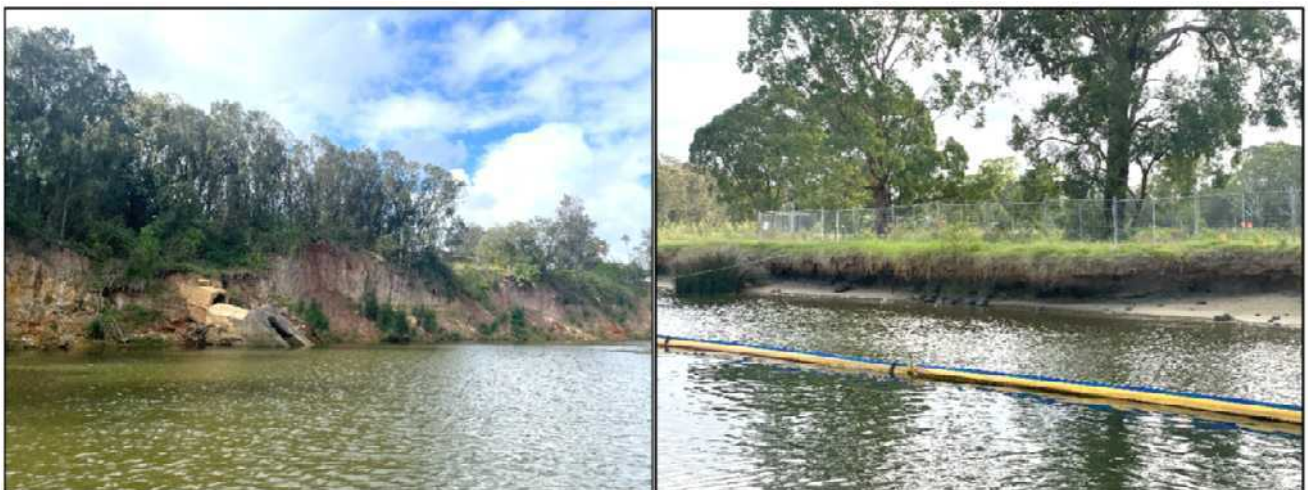
*Plate 6 Examples of Extreme erosion severity in the study area, from left to right: upper Georges River Reach 264; mid Georges River Reach 250.*

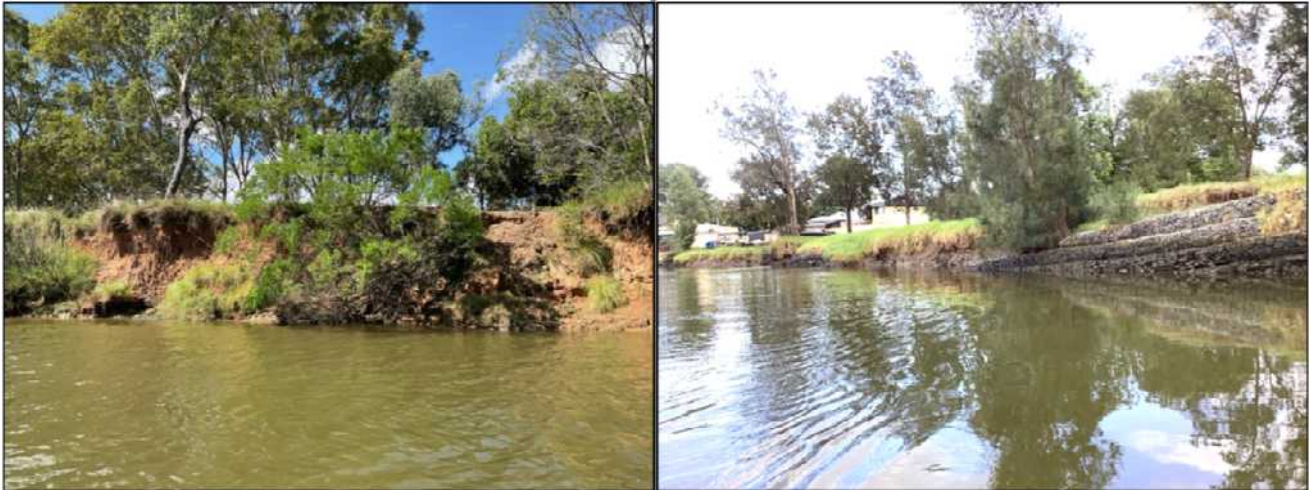
*Plate 7 Examples of High erosion severity in the study area, from left to right: upper Georges River Reach 180; and mid Georges River Reach 26.*

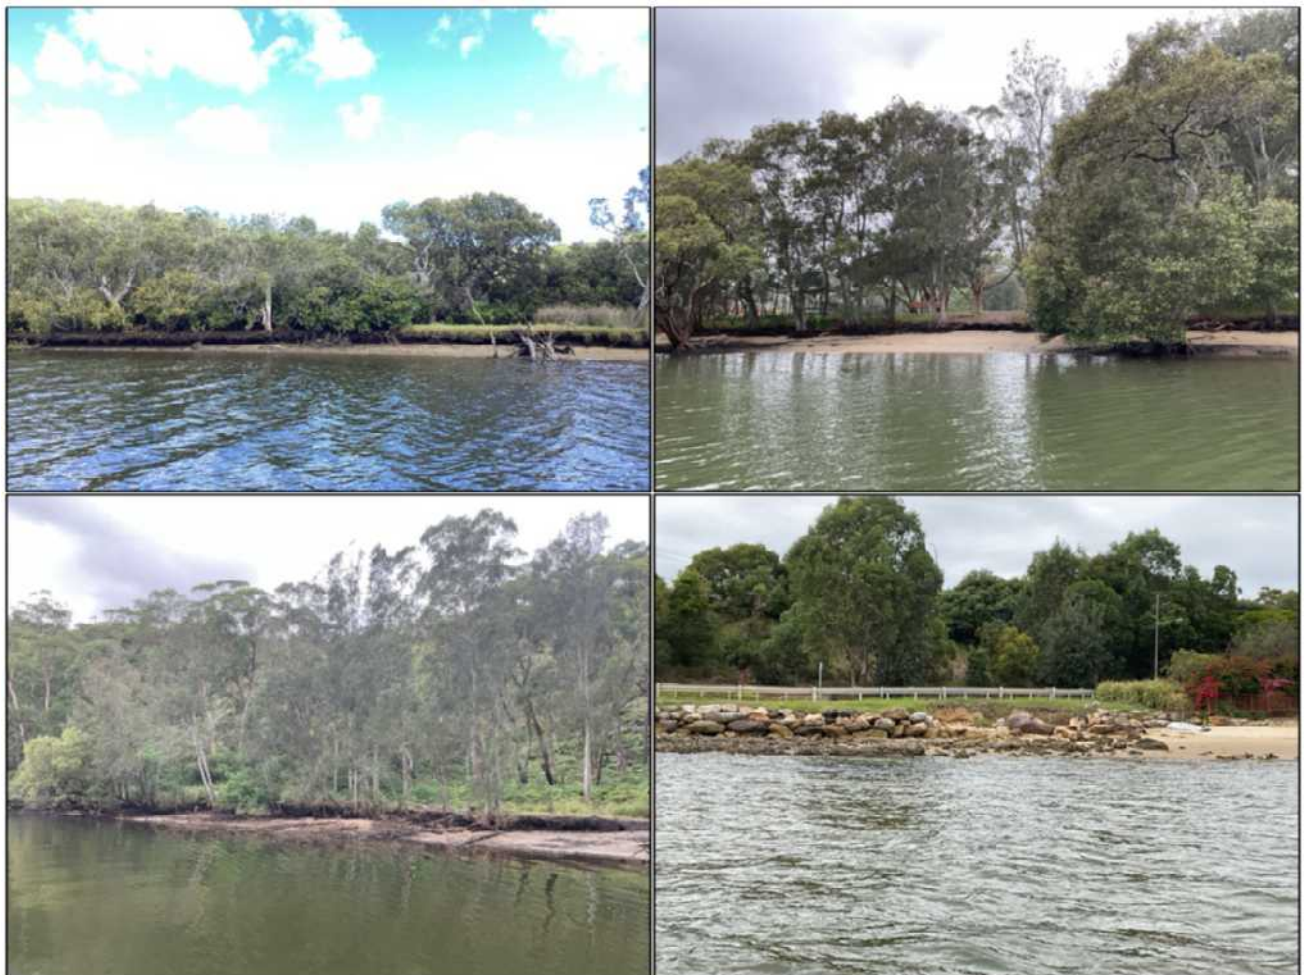
*Plate 8 Examples of Moderate erosion severity in the study area, clockwise from top left: upper Georges River Reach 180; and mid Georges River Reach 26.*

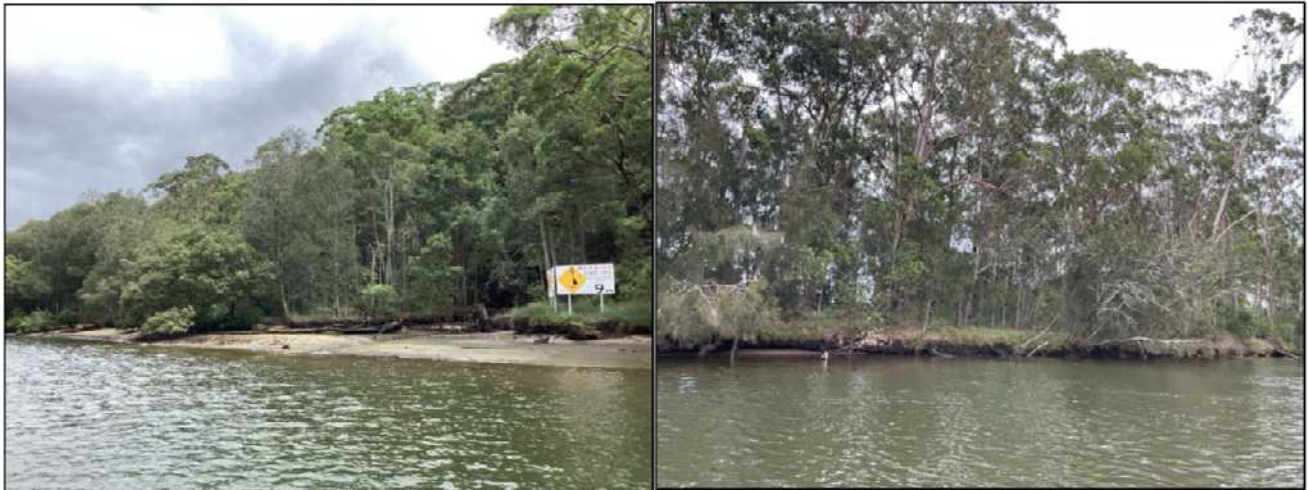
*Plate 9 Examples of Low erosion severity in the study area, from left to right: Woronora River Reach 595; and mid Georges River Reach 358.*

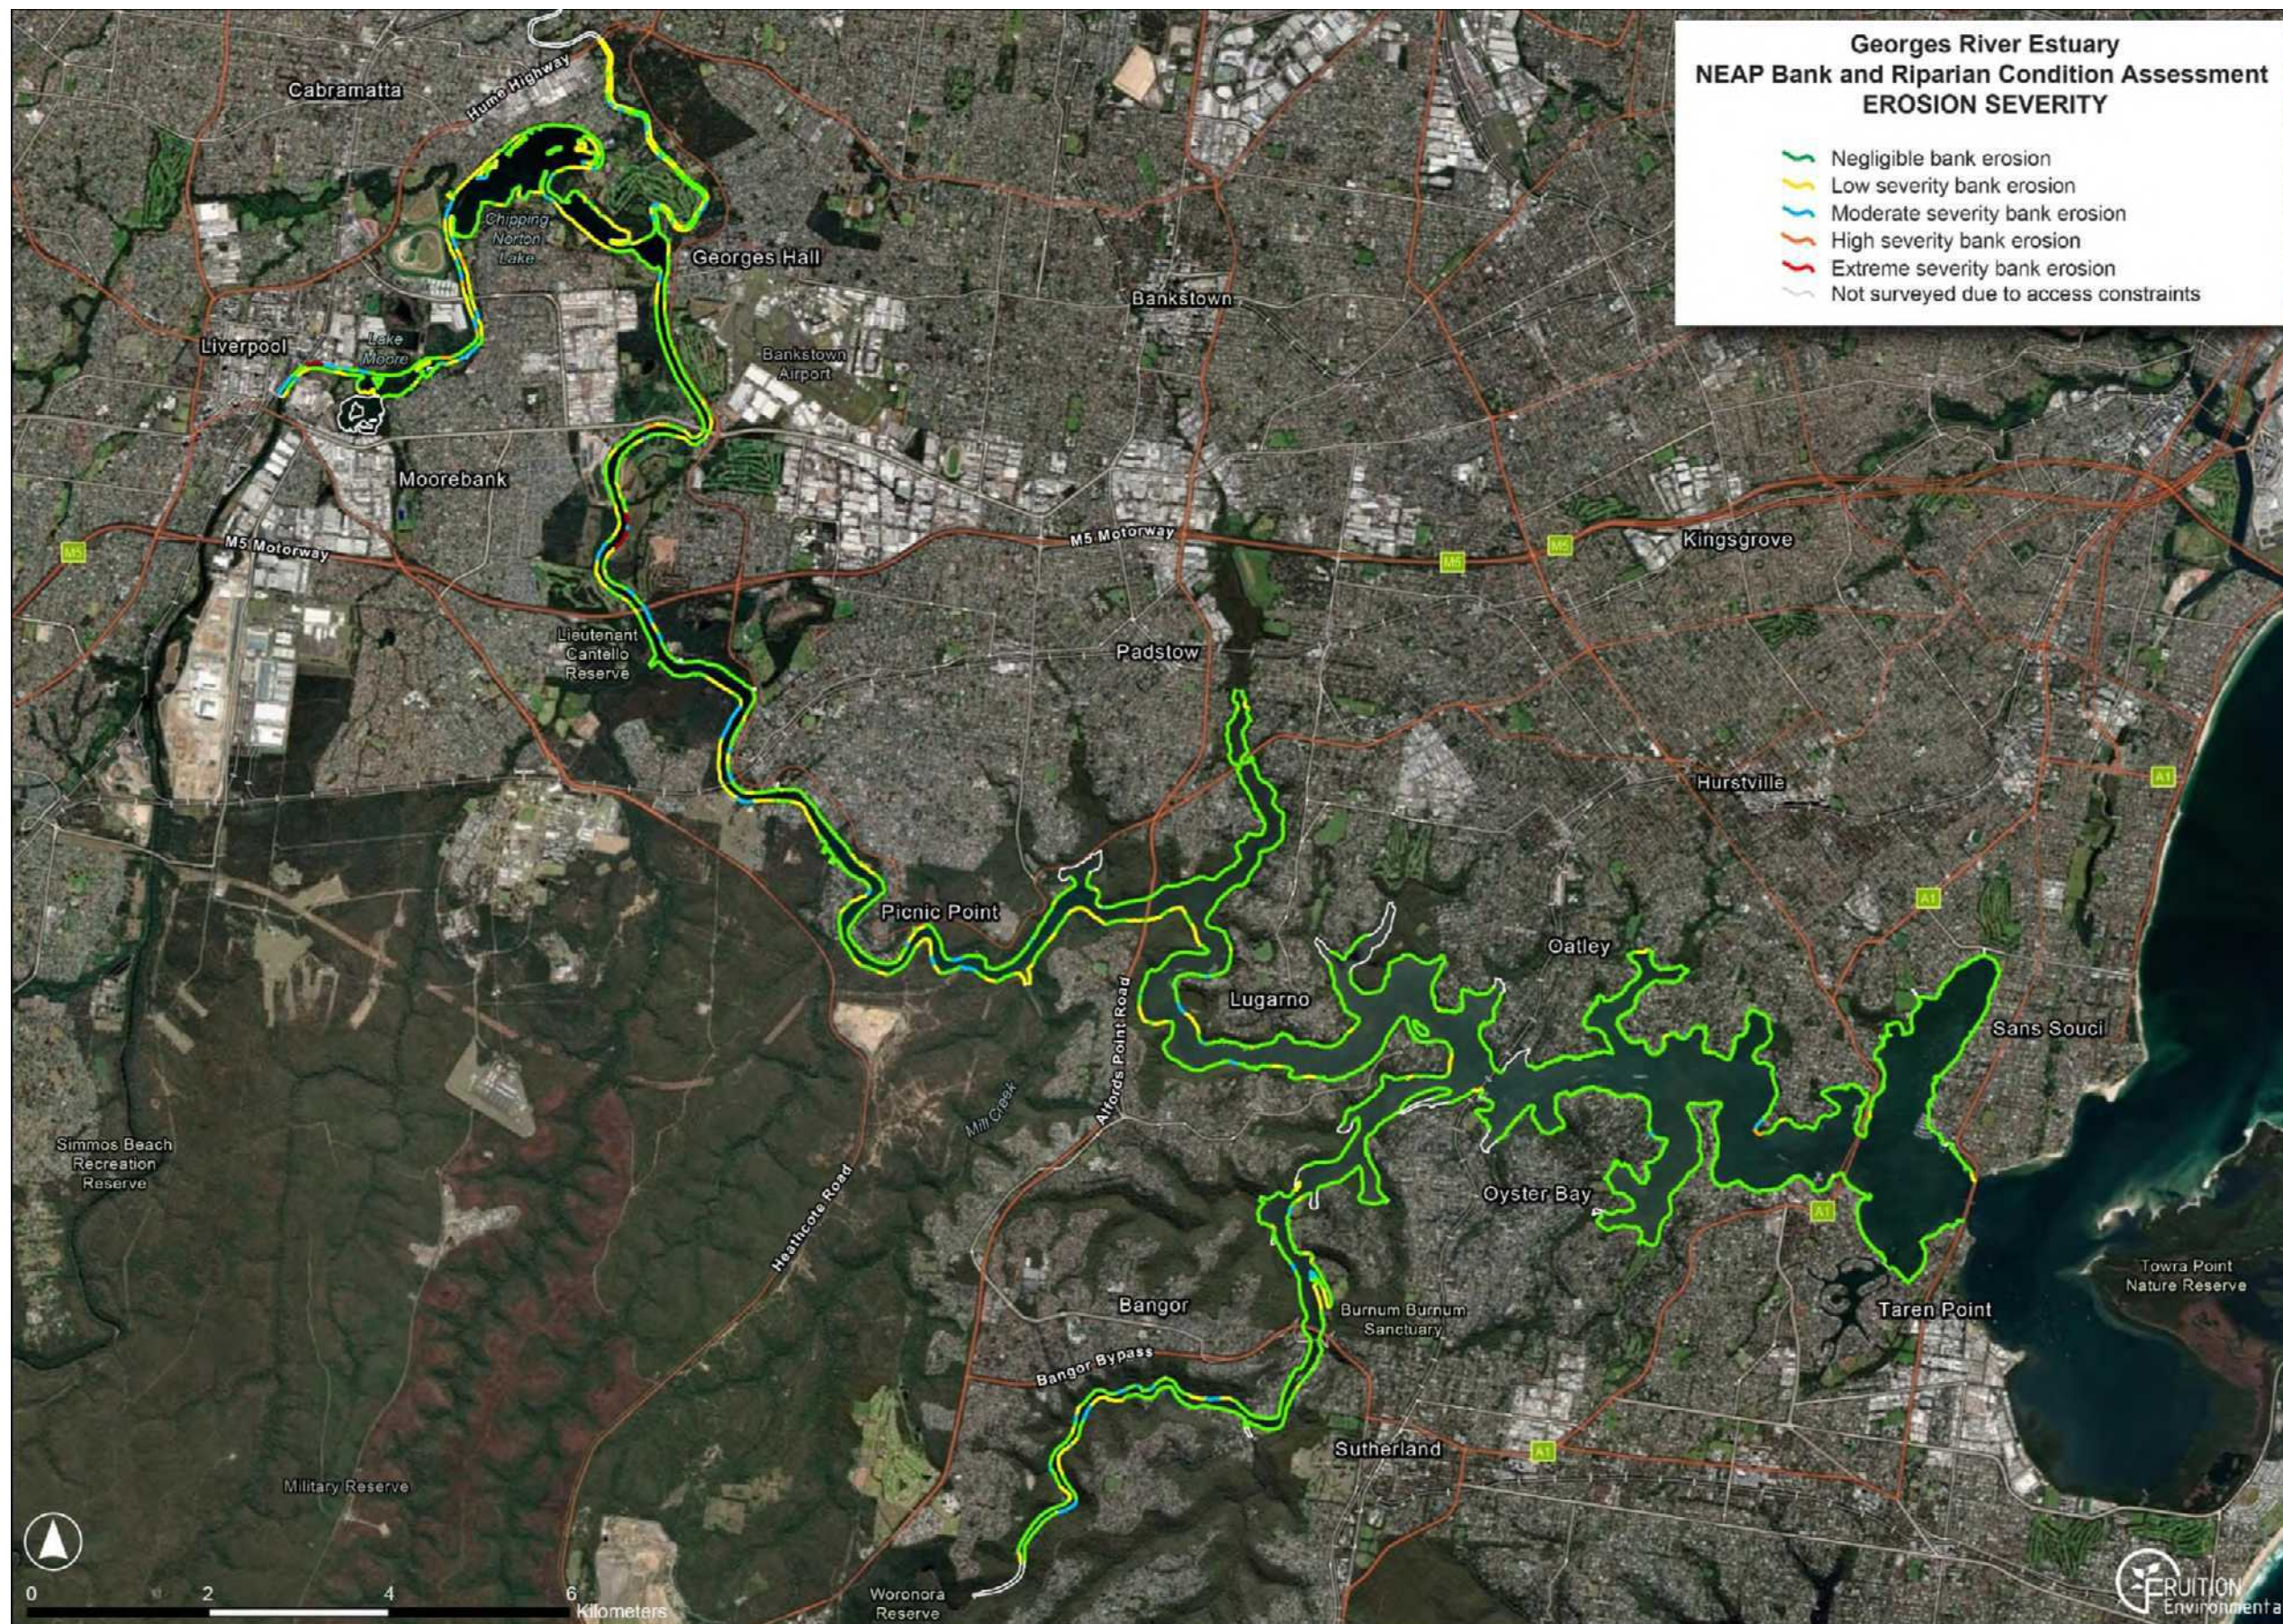
Moderate erosion was observed along 4.8% of the total mapped estuarine banks and was more broadly distributed across multiple process zones. In the Georges River, Moderate erosion was recorded along 2.6 km (8%) of the bank length in the fluvial-dominated zone, and 1.7 km (10.1%) of the fluvial transition zone. Some of these areas may represent reaches recovering from earlier high severity erosion events—such as flood-induced slumping—where natural stabilisation processes are evident. In the Woronora River, Moderate erosion was mostly restricted to isolated upper reaches, totalling approximately 890 m (7.8%), and in proximity to boat ramps at Bonnet Bay and Burnum Burnum. These moderately eroded reaches typically exhibited minimal toe scour, with bank instability primarily associated with riverine or tidal flows and boat wake, leading to wave notching and subsequent bank slumping.

Figure 15 Distribution of mapped bank erosion severity across the Georges River Estuary Study Area.

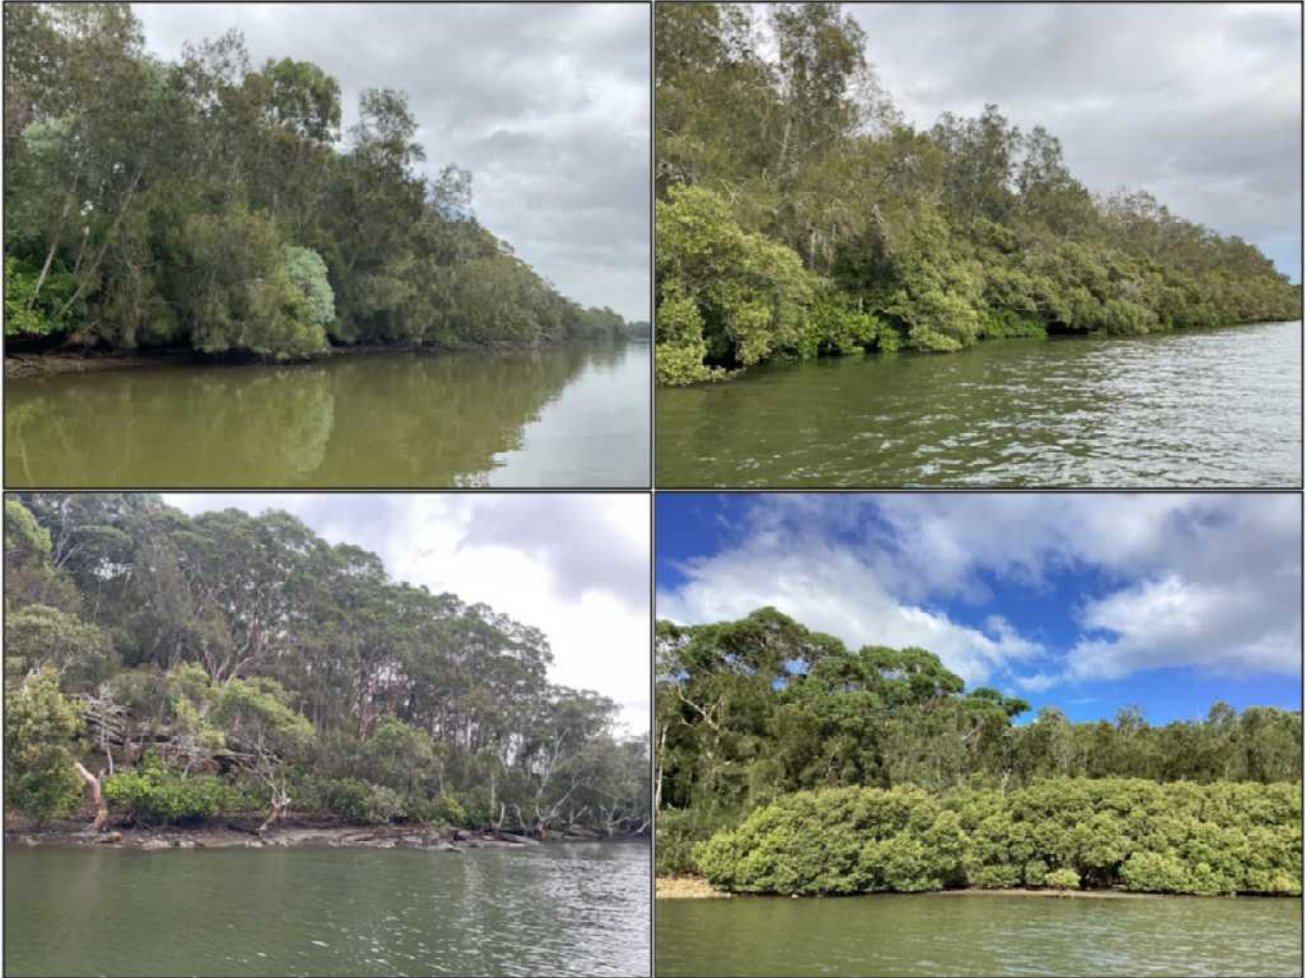
**Plate 10** *Examples of Very Good condition riparian vegetation within the study area, clockwise from top left: upper Georges River Reach 89; mid Georges River Reach 265; lower Georges River Reach 910; and Woronora River Reach 531.*

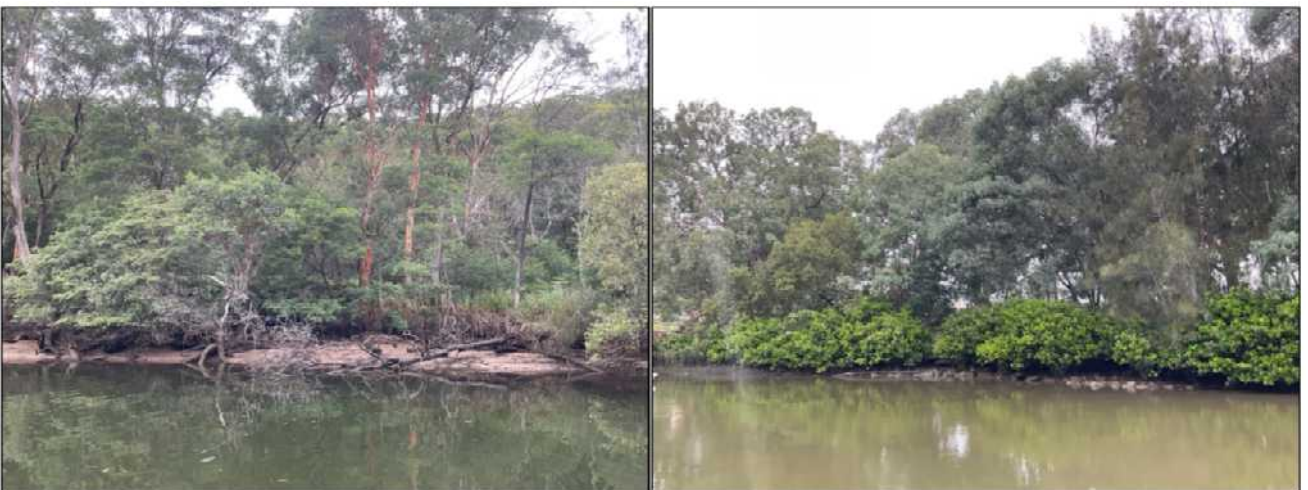
**Plate 11** *Examples of Good condition riparian vegetation within the study area, from left to right: upper Georges River Reach 50; and Woronora River Reach 650.*

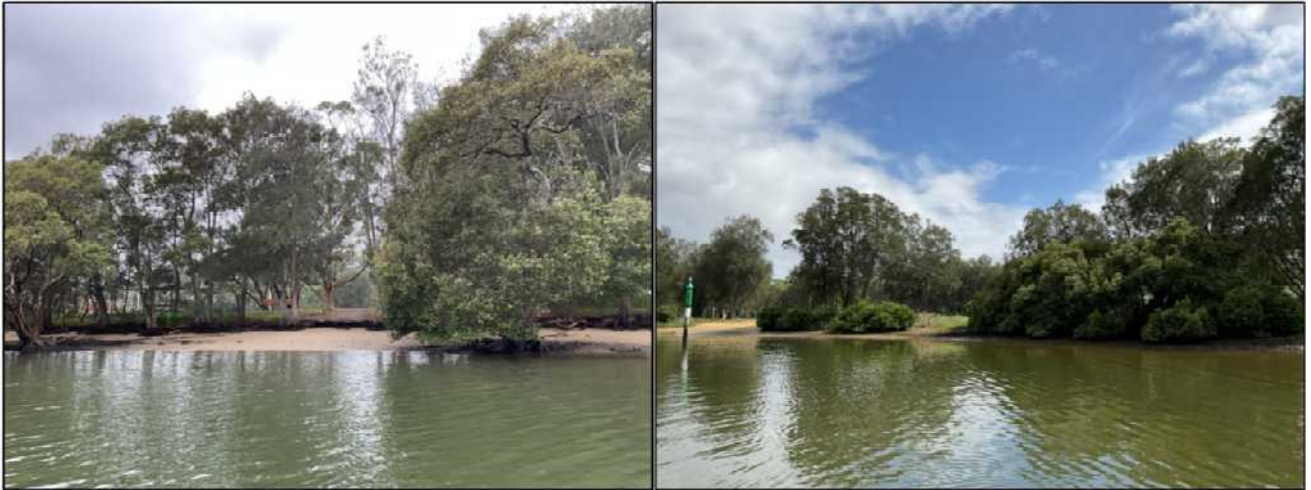
**Plate 12**      *Examples of Moderate condition riparian vegetation within the study area, from left to right: Woronora River Reach 540; and mid Georges River Reach 333.*

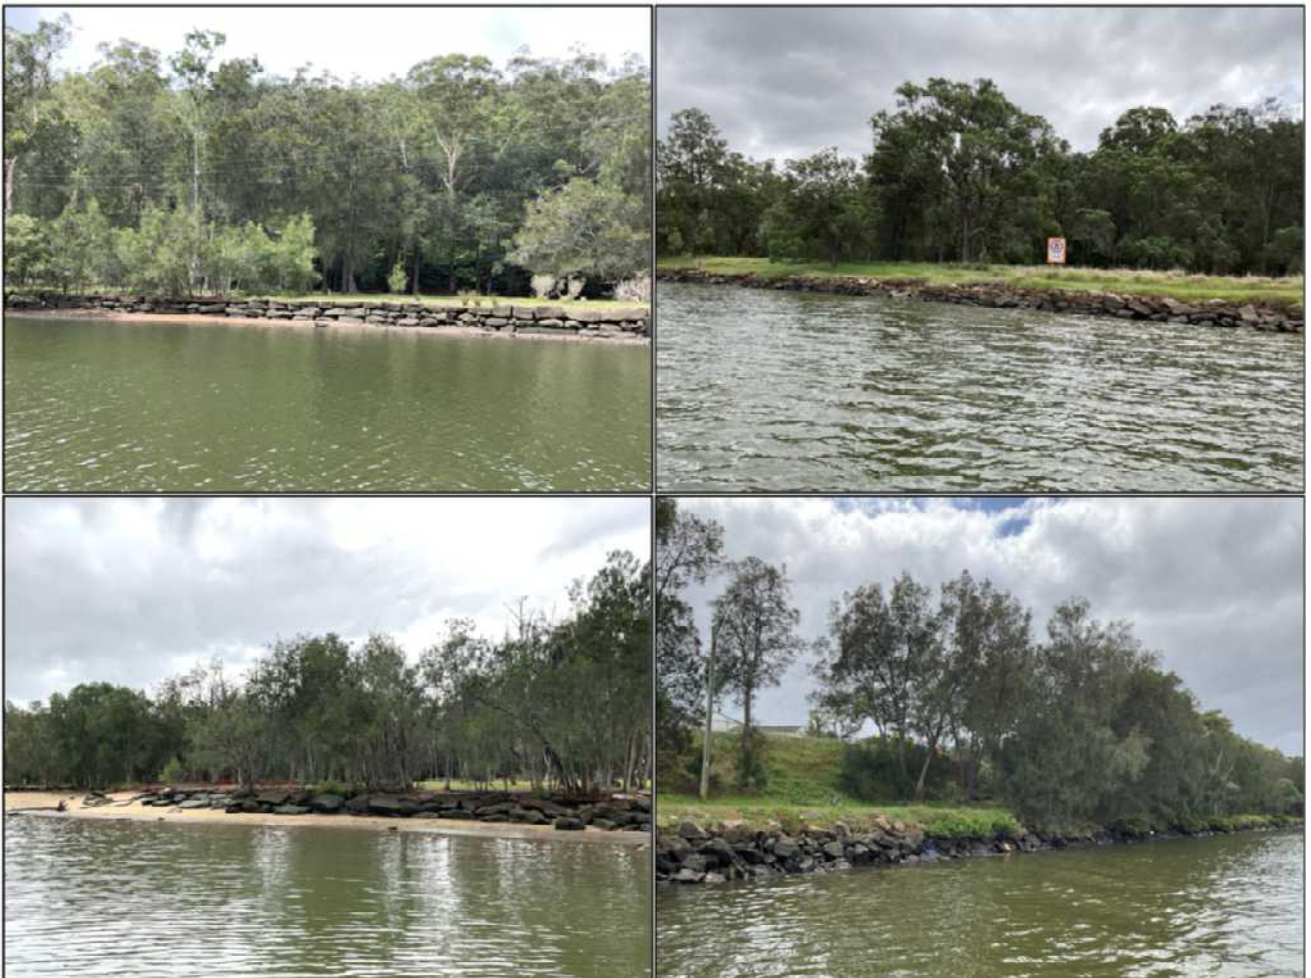
**Plate 13**      *Examples of Poor condition riparian vegetation within the study area, clockwise from top left: Woronora River Reach 601; mid Georges River Reach 404; upper Georges River Reach 129; and Woronora River Reach 574.*

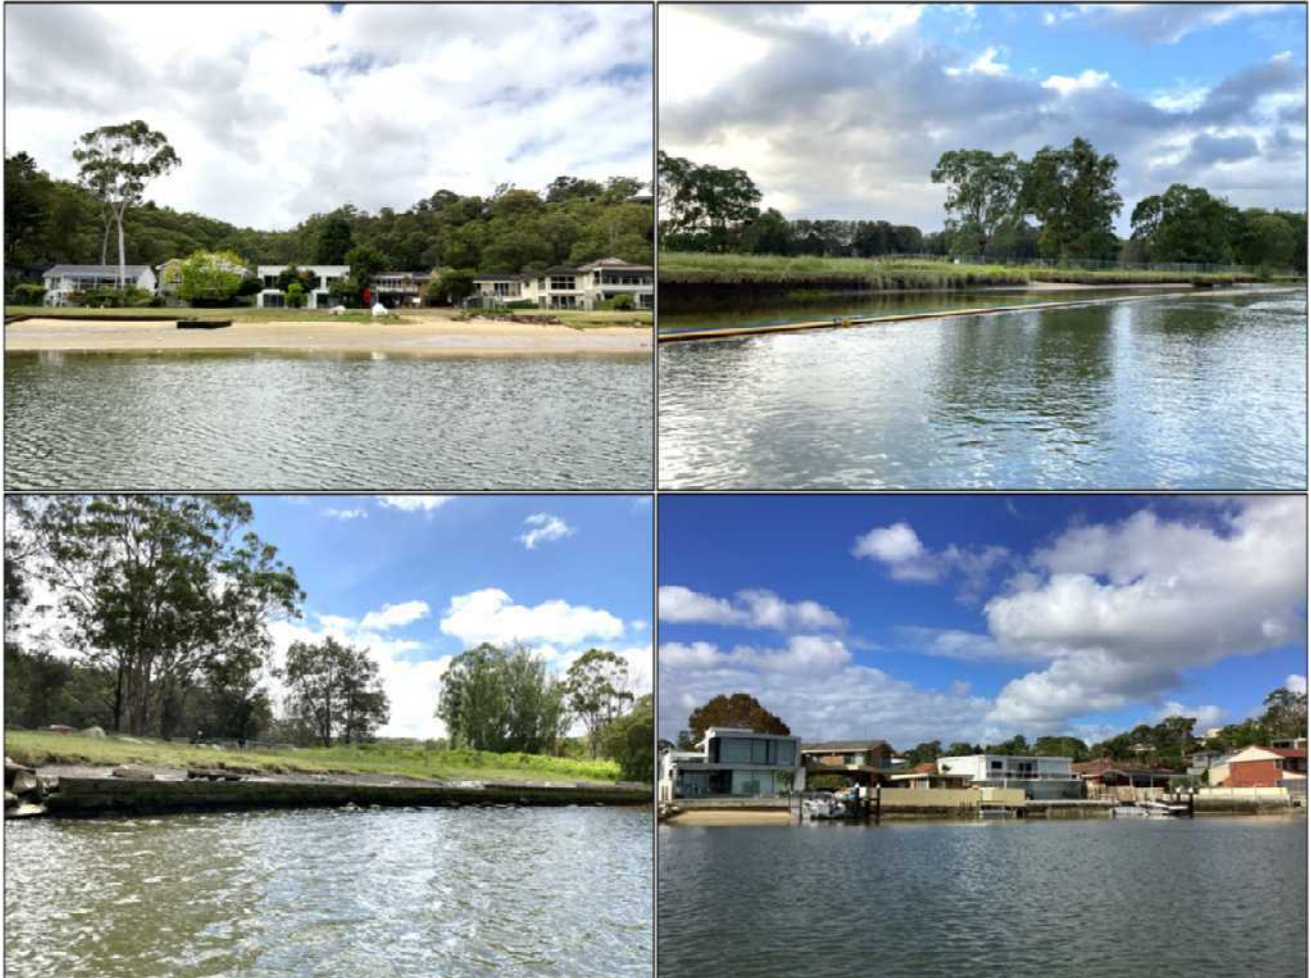
*Plate 14 Examples of Very Poor condition riparian vegetation within the study area, clockwise from top left: Woronora River Reach 589; mid Georges River Reach 250; lower Georges River Reach 908; mid Georges River Reach 397.*

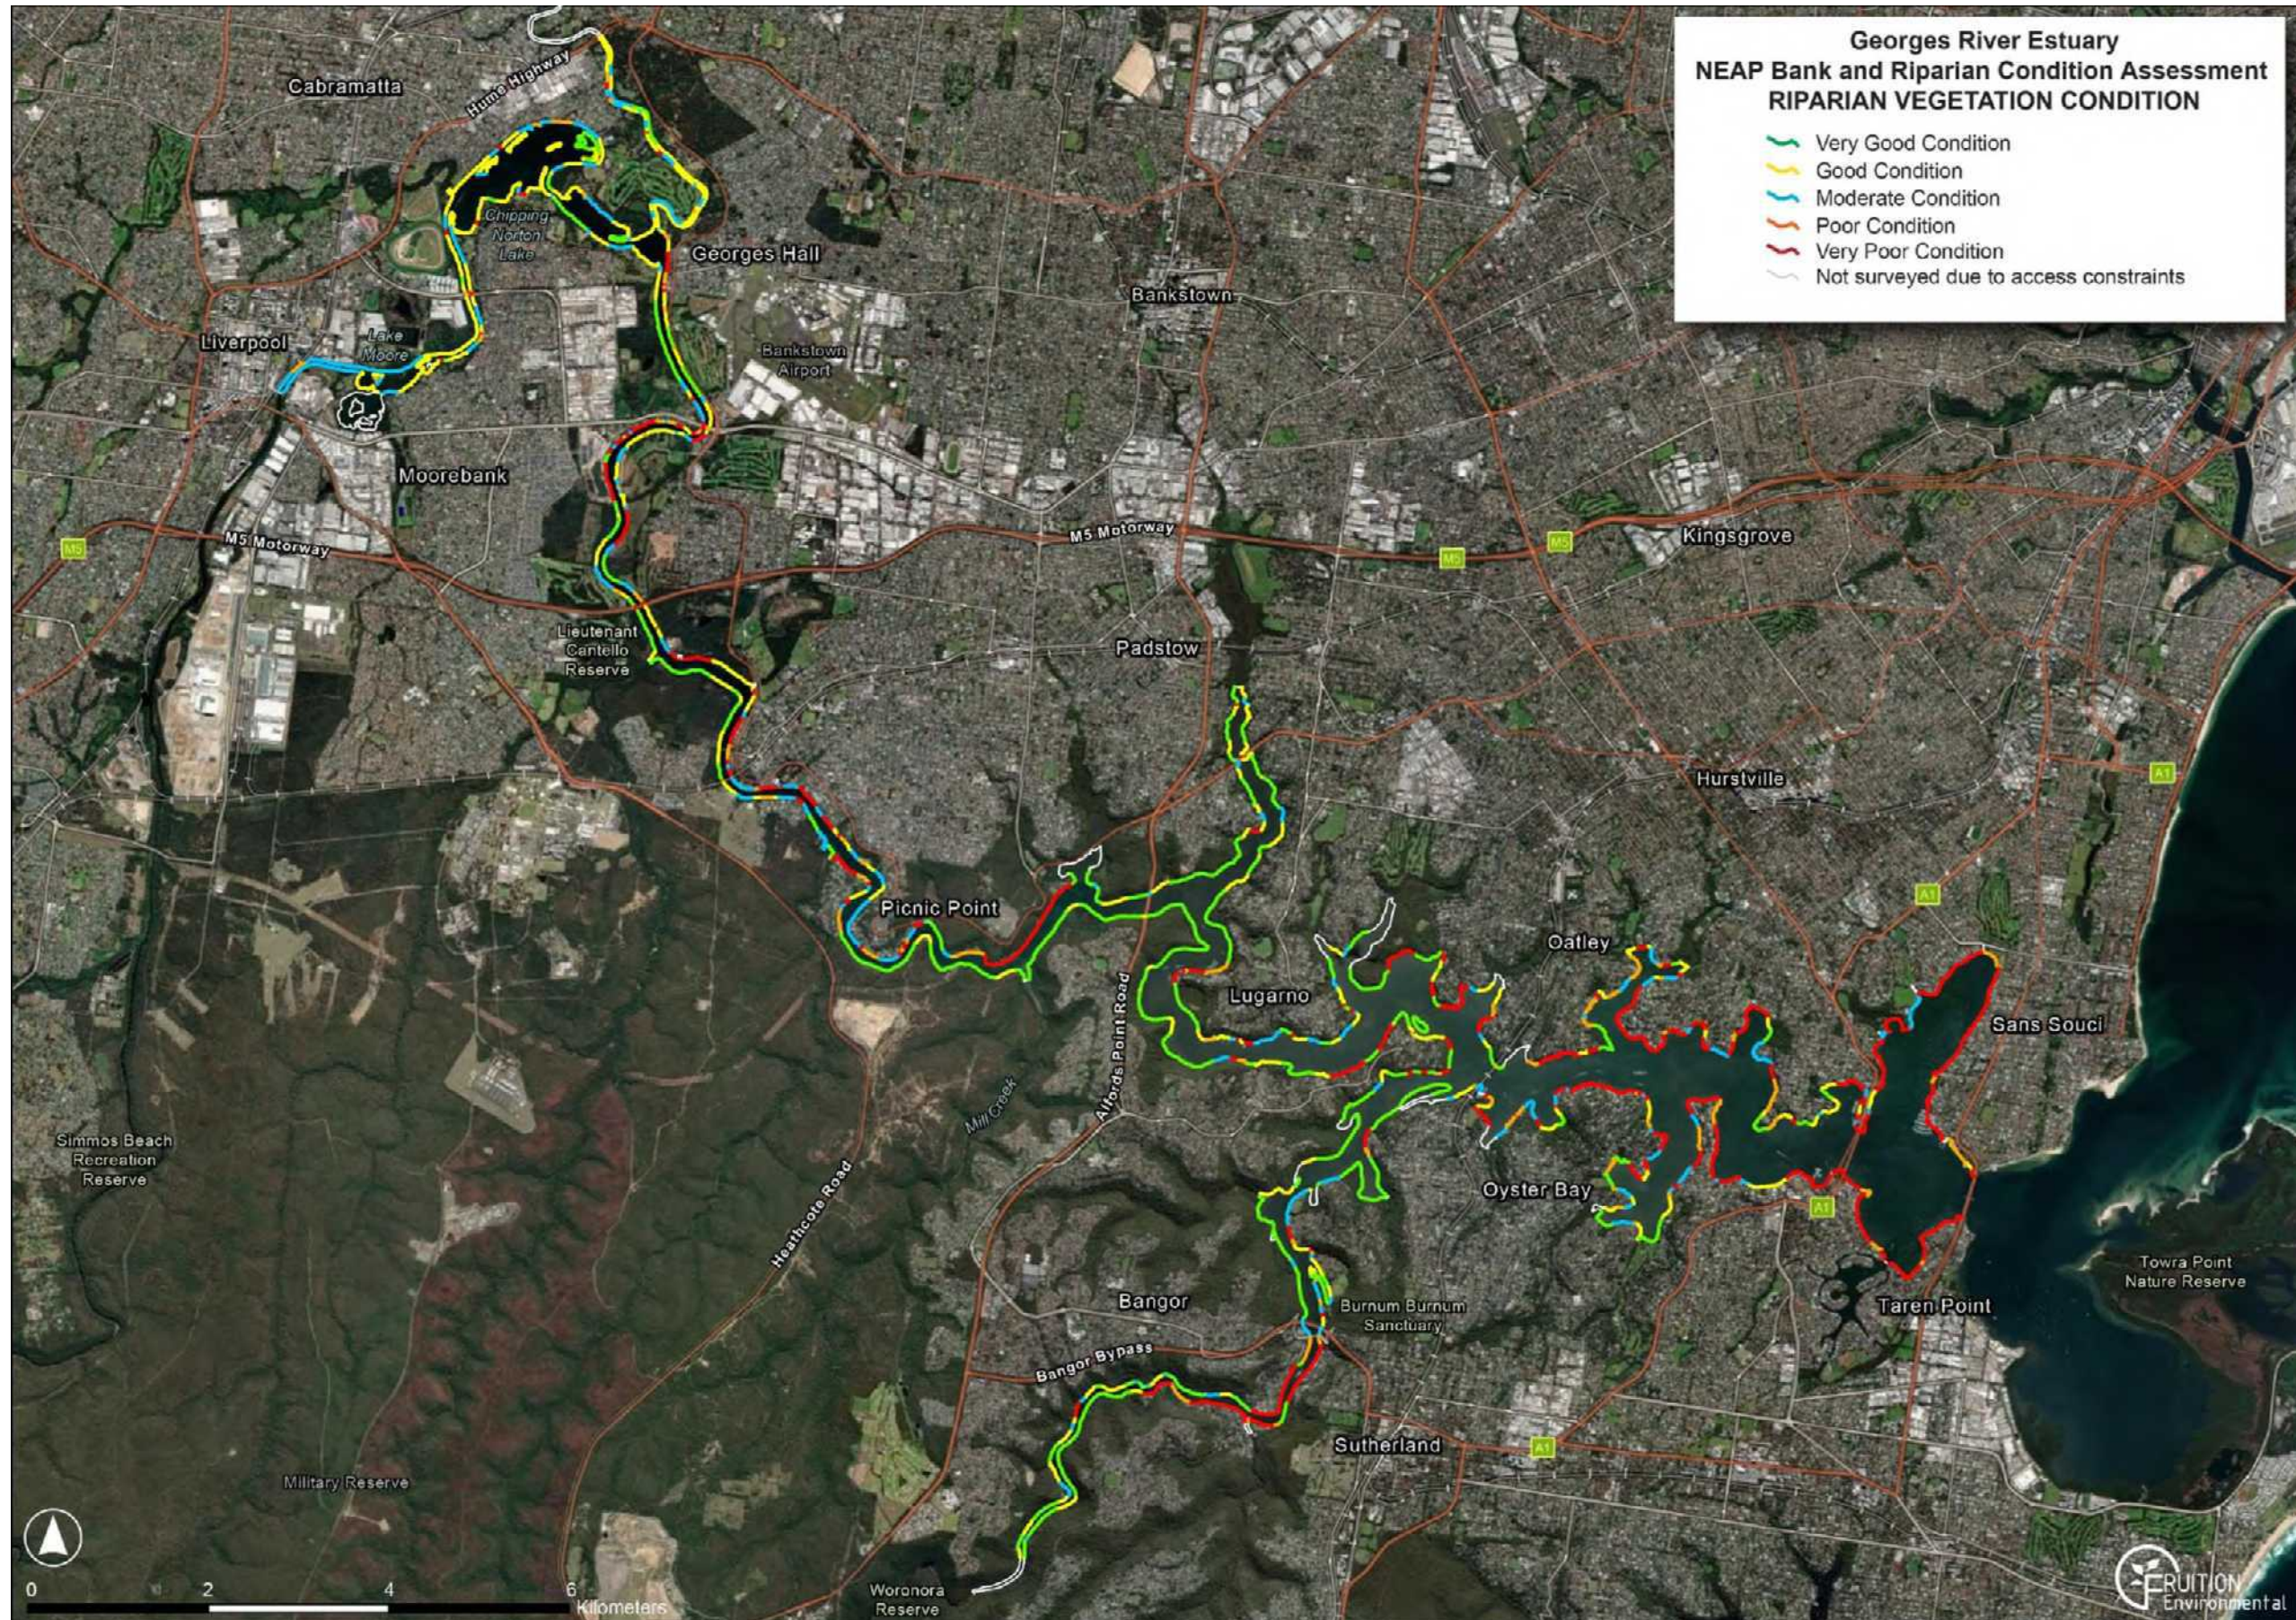
Figure 17 Distribution of riparian vegetation condition across the Georges River Estuary Study Area.

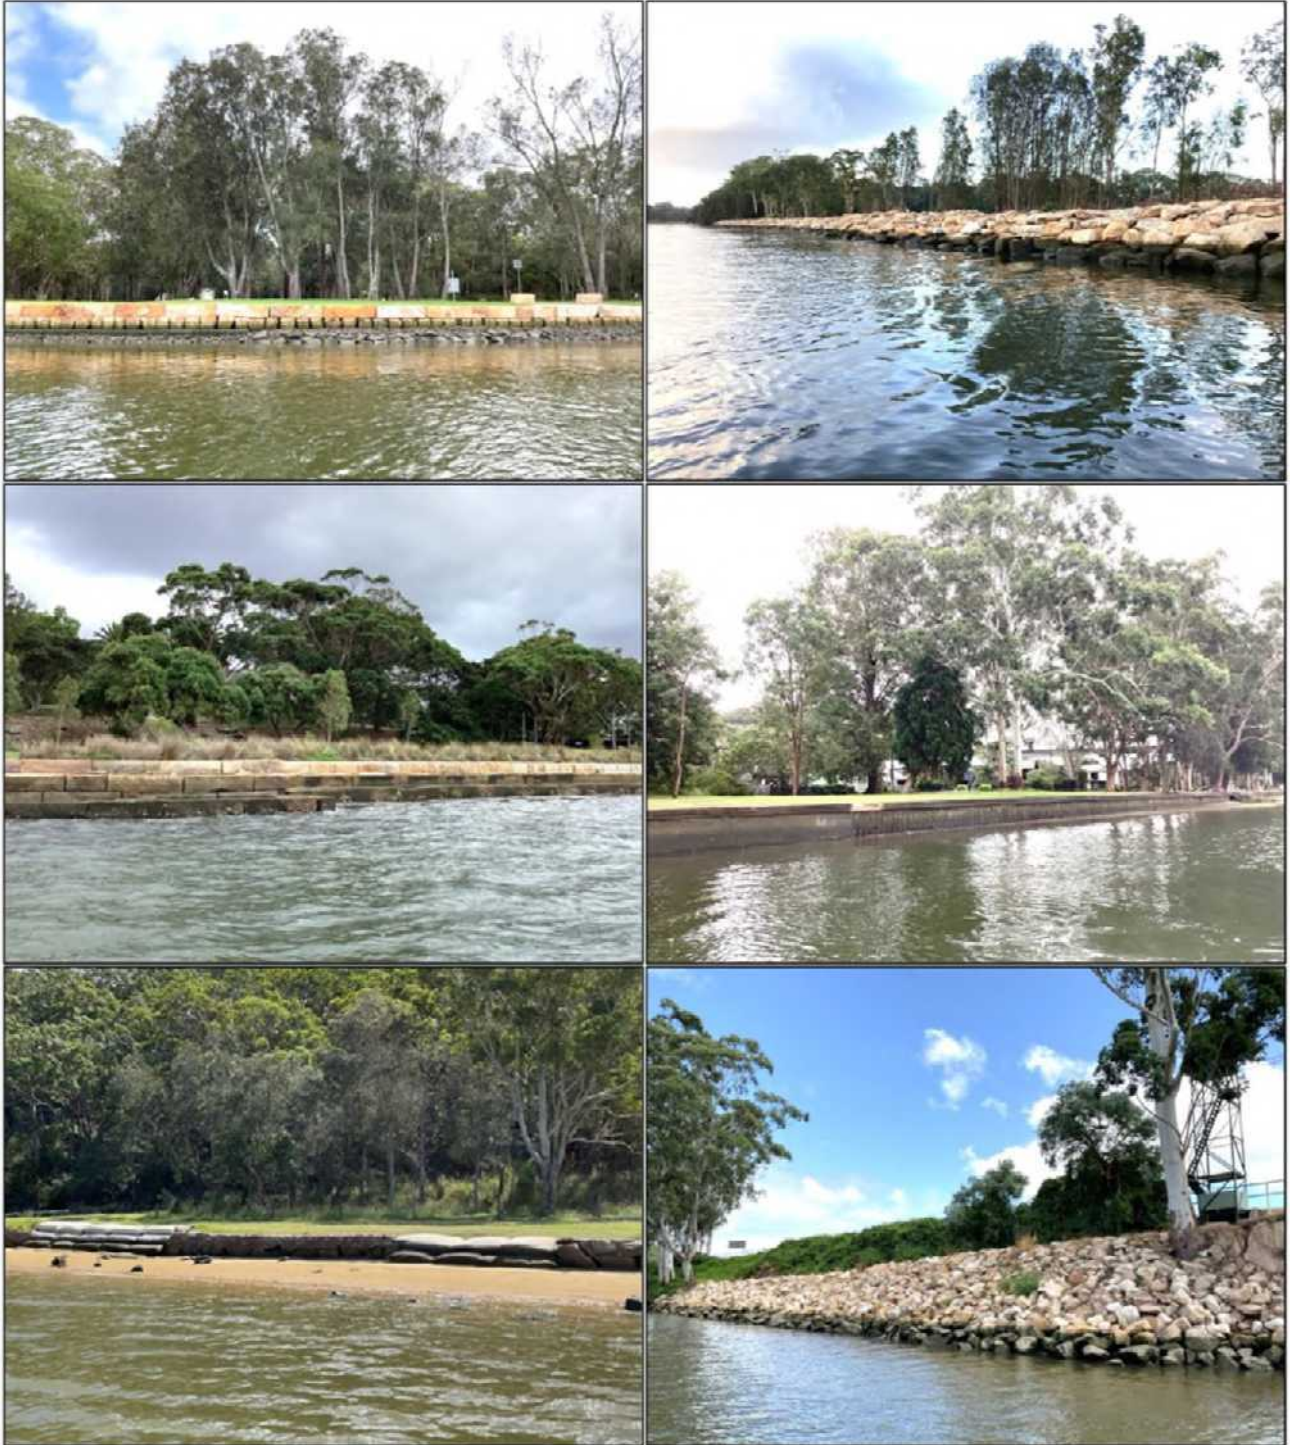
**Plate 15** *Examples of effective bank protection works in the Georges River estuary, clockwise from top left: sandstone block wall and rock armour toe on the mid Georges River Reach 291; upper Georges River Reach 162; geotextile sandbags used in a public access location on the mid Georges River at Reach 426; and rocky foreshore habitat restoration at Carss Park Reach 989.*

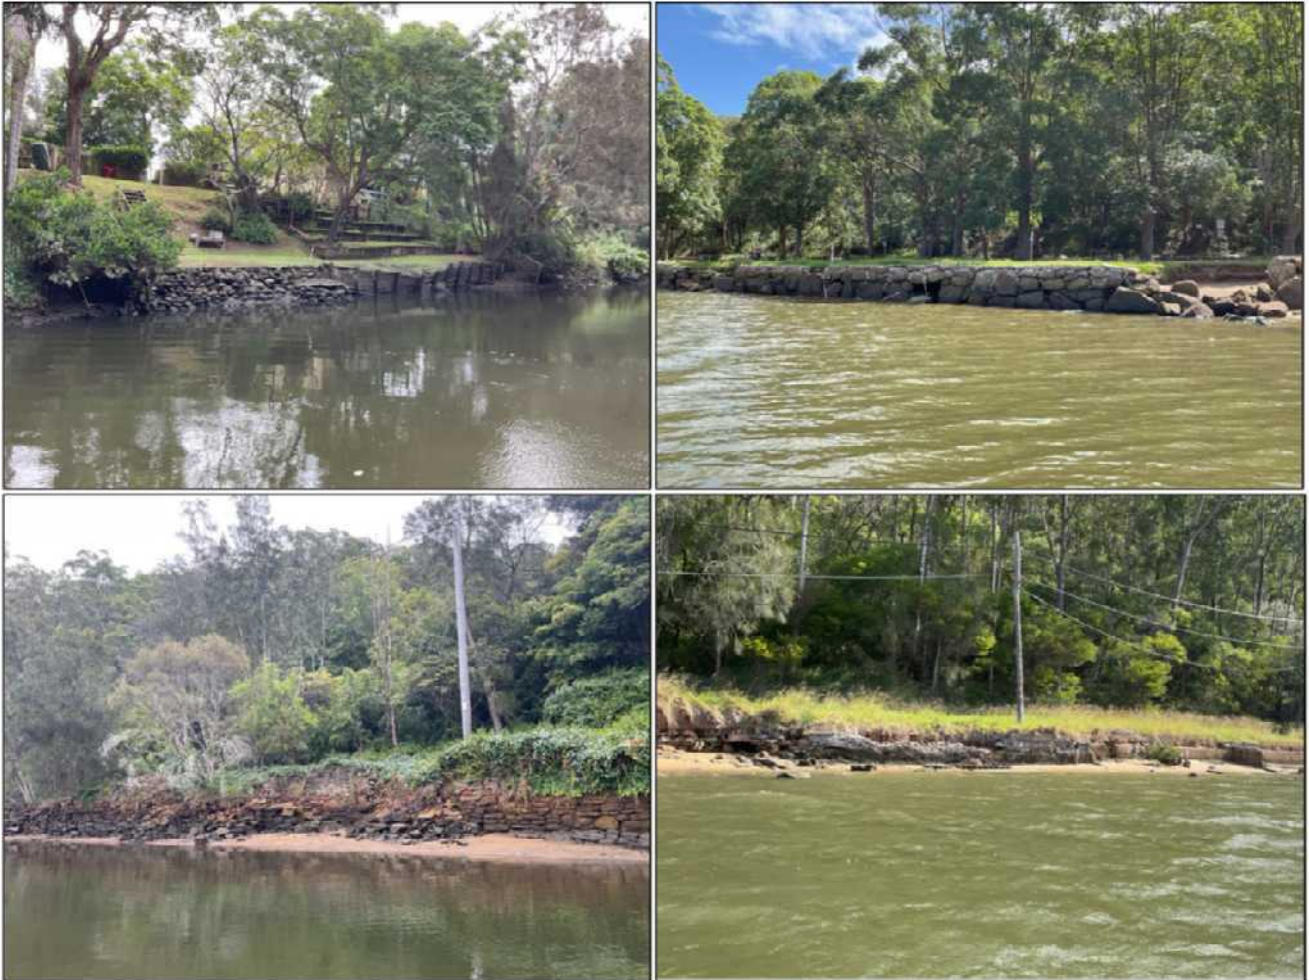
**Plate 16** *Examples of partially effective bank protection works in the Georges River estuary, clockwise from top left: failing timber wall in Prospect Creek Reach 1093; failing rock wall adjacent to public park area in mid Georges River Reach 416; failing gabions and concrete wall in the lower Georges River Reach 463; and failing rock wall in the Woronora River Reach 636.*

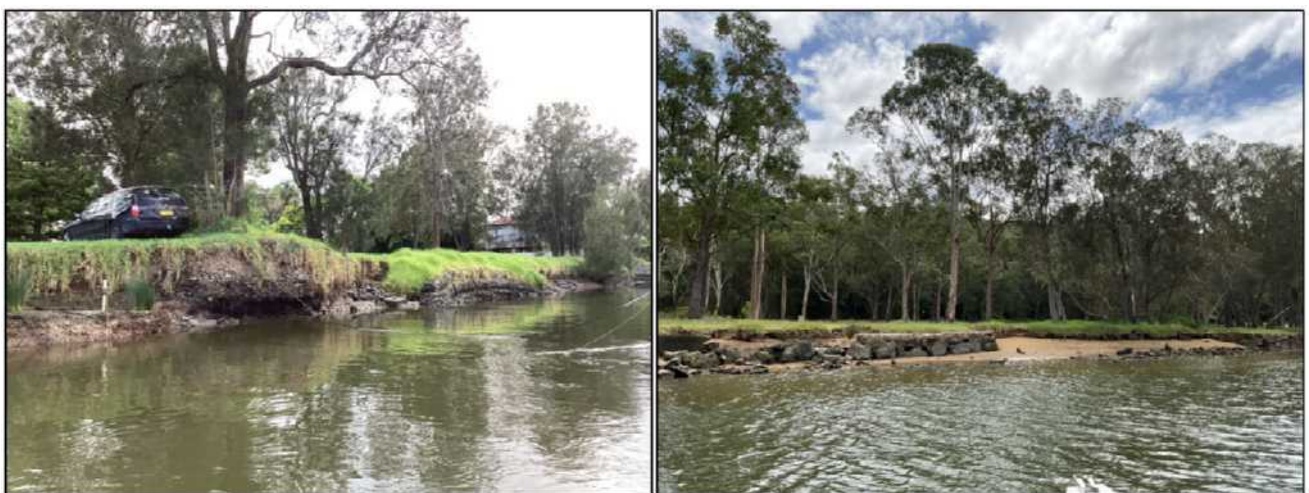
**Plate 17** *Examples of ineffective bank protection works in the Georges River estuary, from left to right: failed gabion structures on the upper Georges River Reach 26; and failed rock works with concrete capping on the mid Georges River Reach 394.*

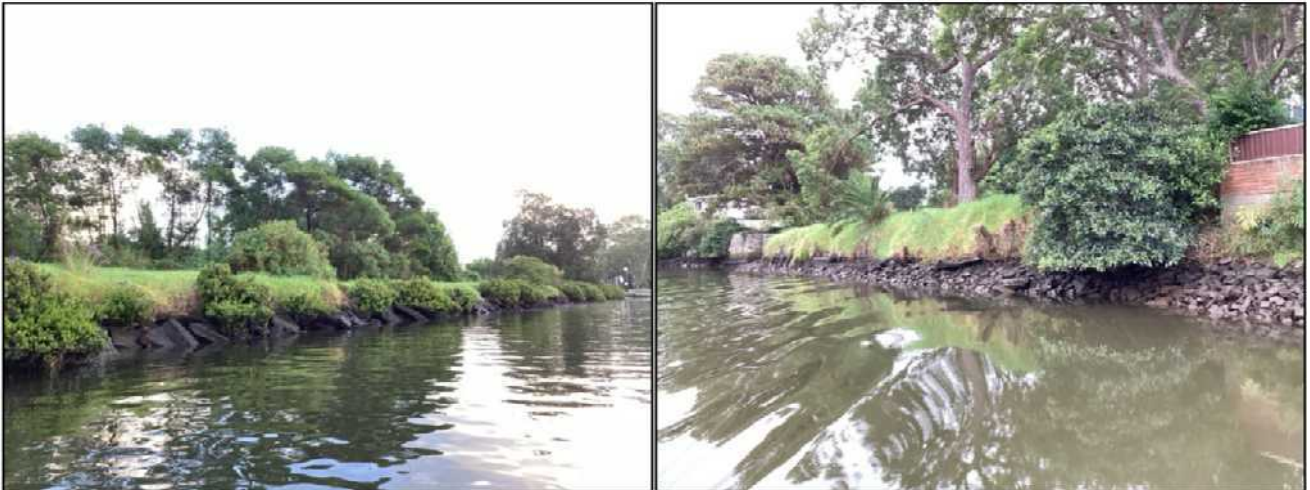
**Plate 18** Examples of inappropriate bank protection works in the Georges River estuary, from left to right: dumped concrete slabs on the mid Georges River Reach 9; and building rubble used for bank protection in the upper Georges River Reach 35.
