# Georges River Estuary NEAP Bank Erosion and Riparian Condition Assessment Report

3 July 2025

Description: **Georges River Estuary – NEAP Bank Erosion and Riparian Vegetation Condition Assessment Report.**

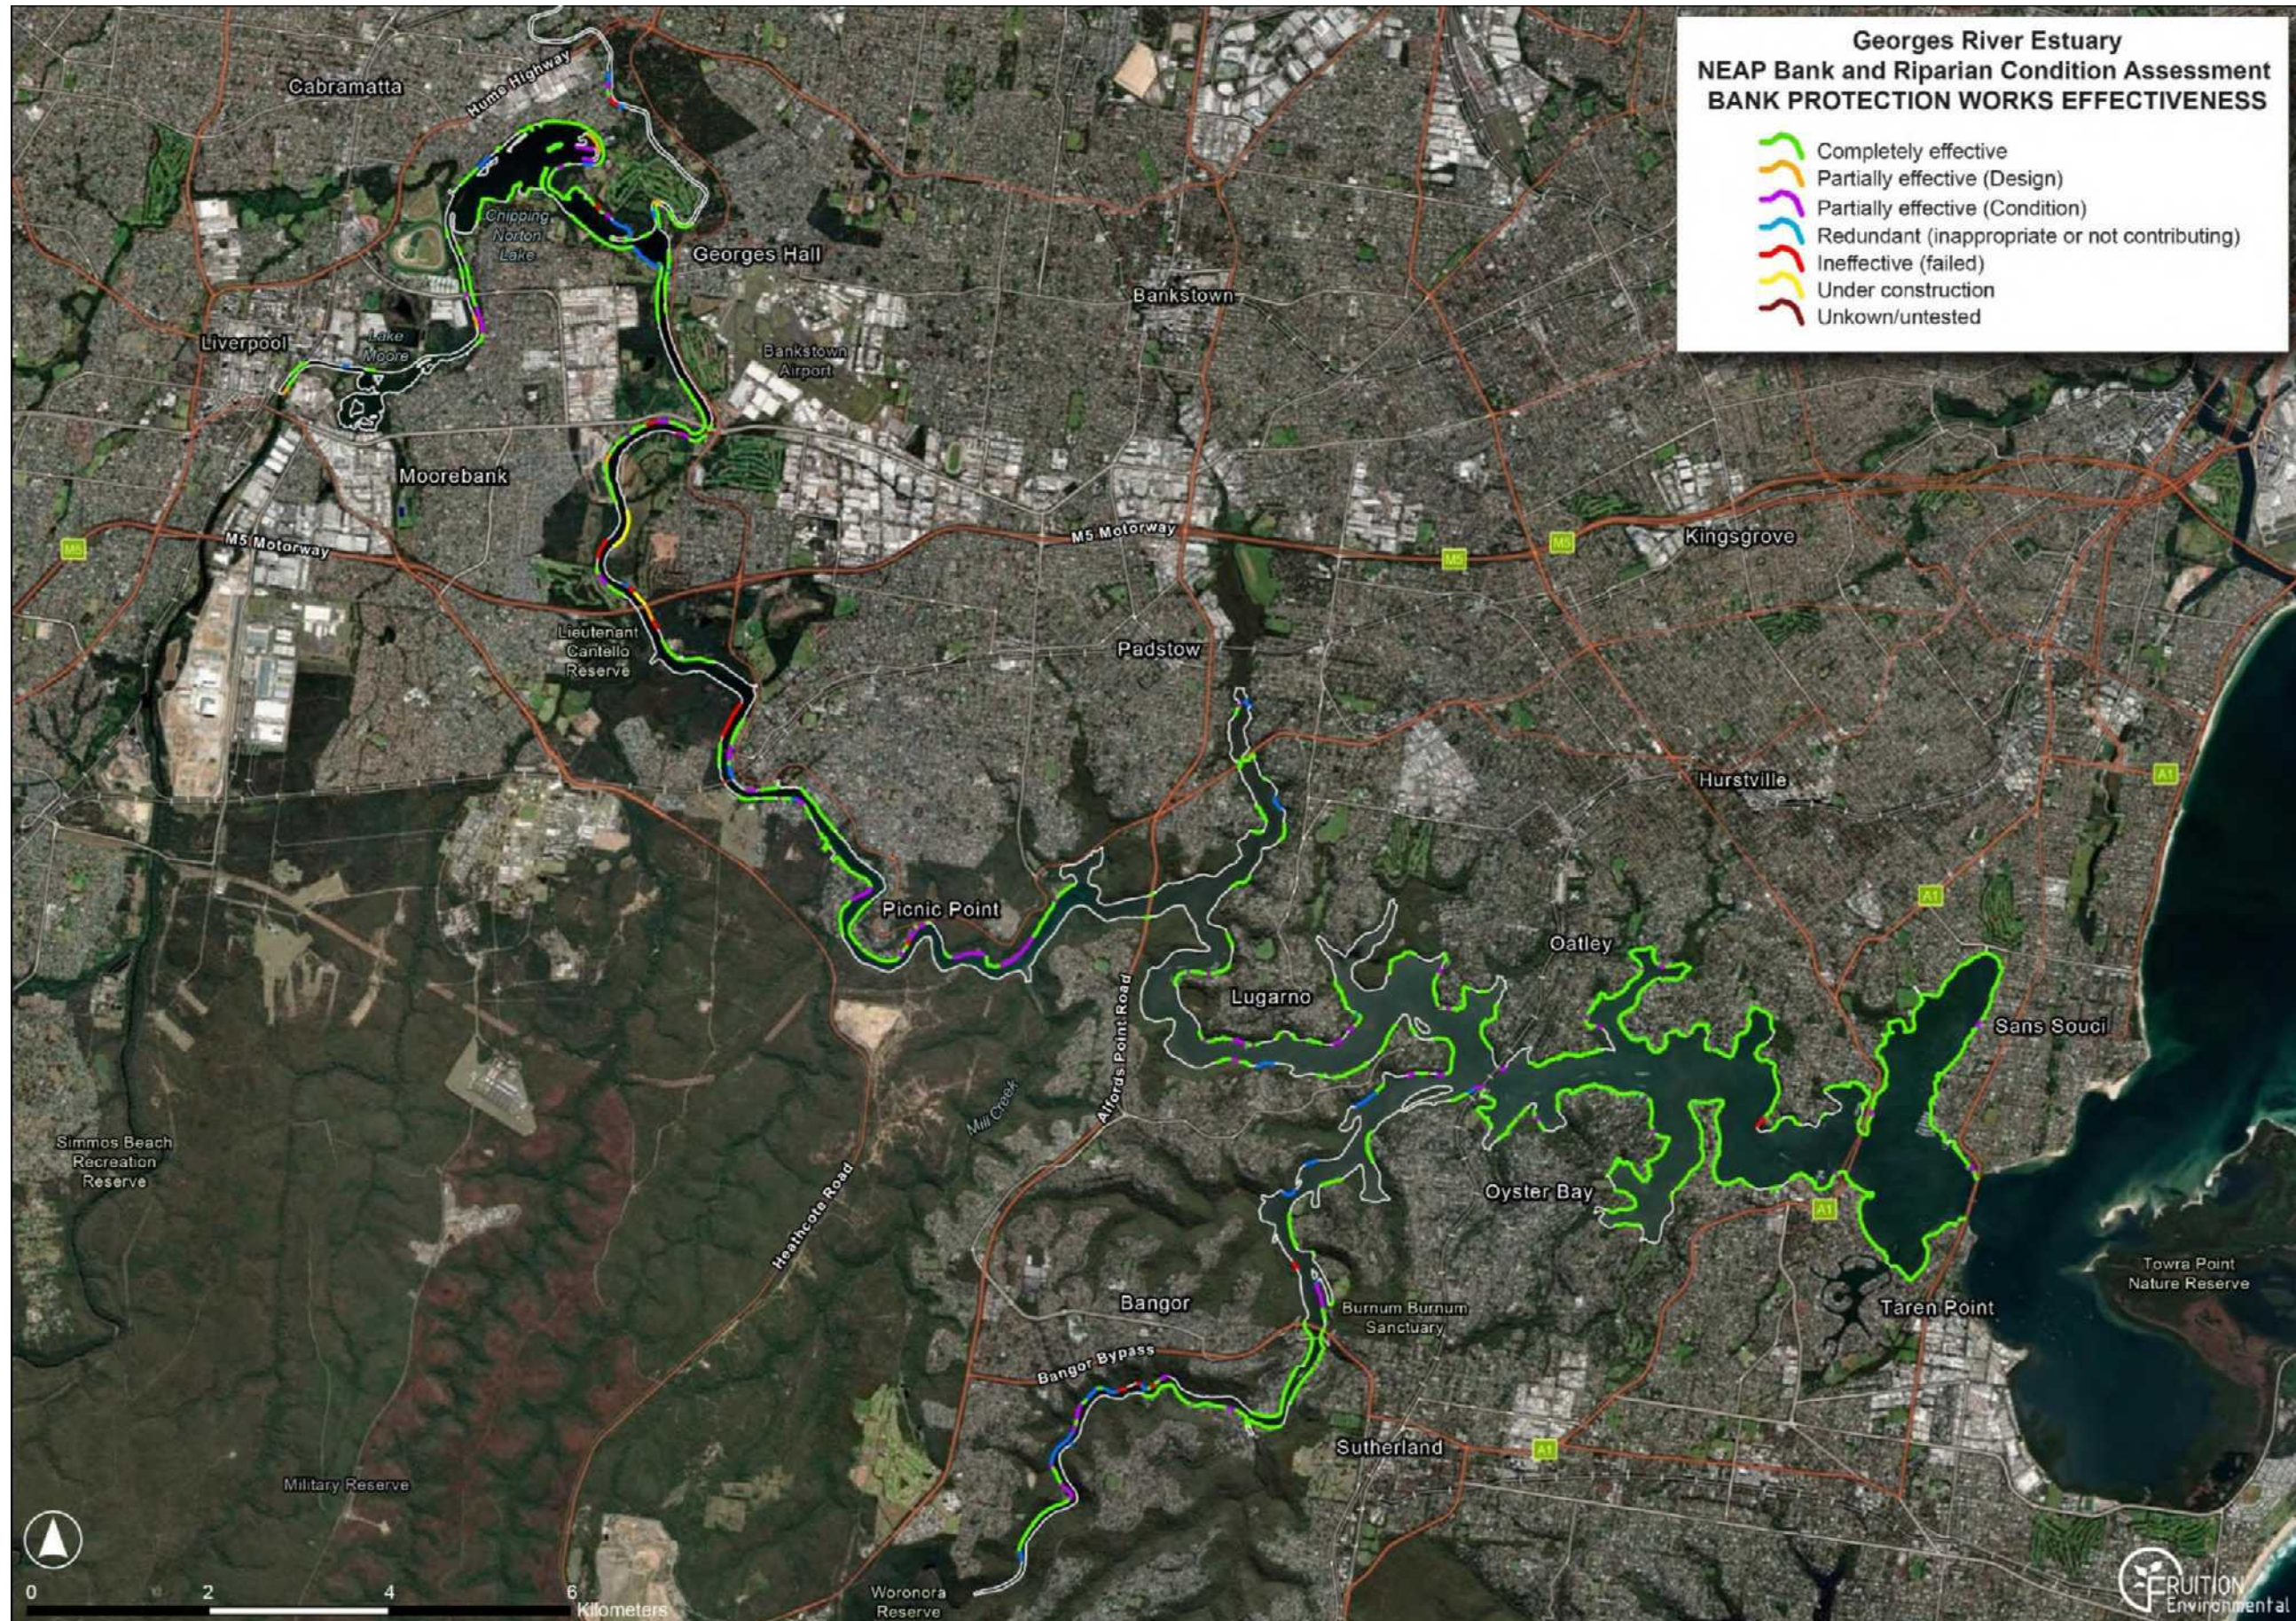
Figure 19 Distribution of bank protection works effectiveness within the Georges River estuary study area.

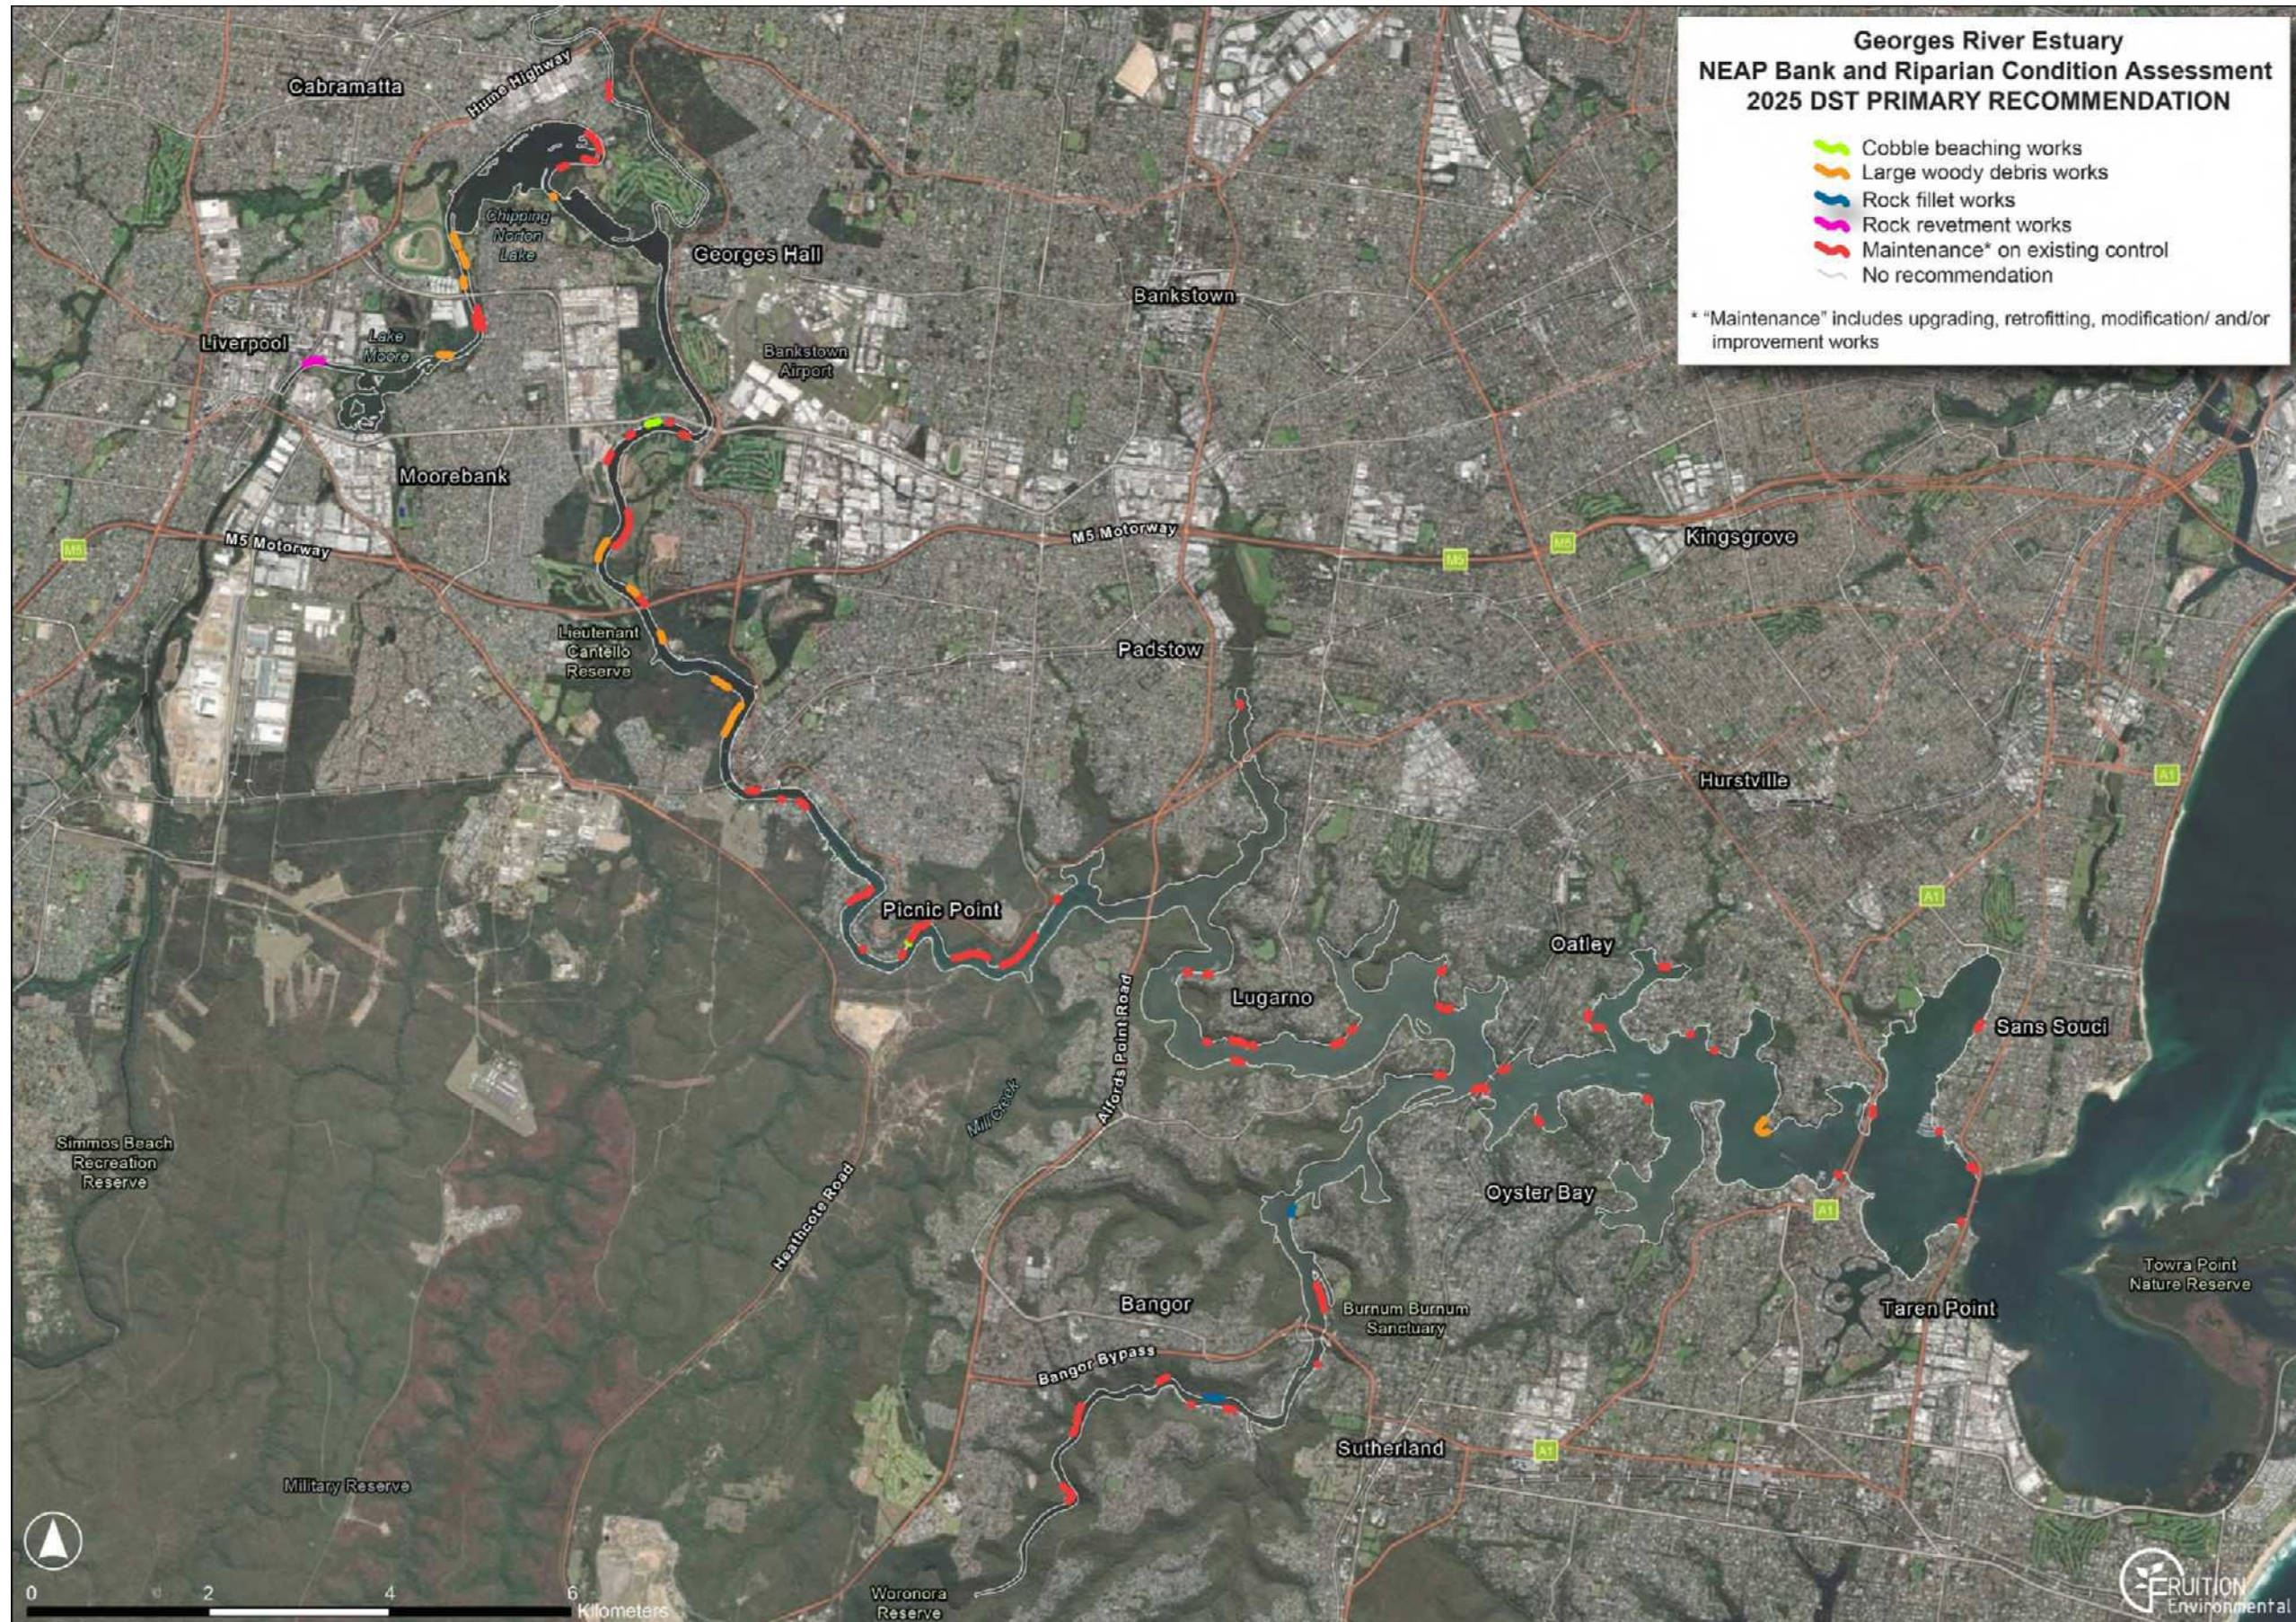
Figure 20 Primary DST recommendations in the Georges and Woronora River estuaries based on the NSW Fisheries Decision Support Tool for Bank Erosion Management in NSW Estuaries (Hydrosphere, 2020).
