# Georges River Estuary NEAP Bank Erosion and Riparian Condition Assessment Report

3 July 2025

Description: **Georges River Estuary – NEAP Bank Erosion and Riparian Vegetation Condition Assessment Report.**

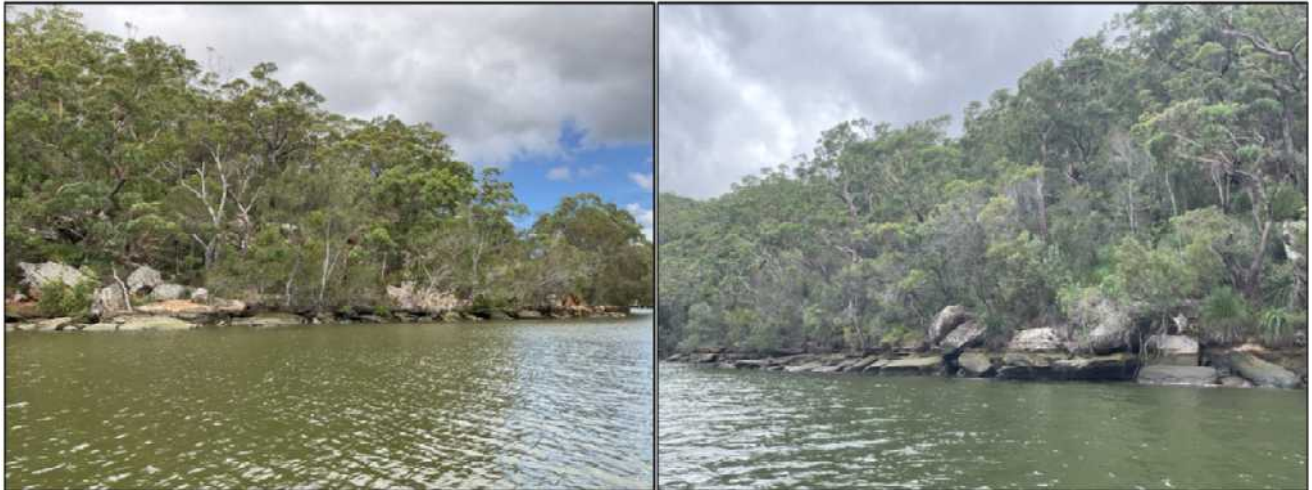
On the Georges River, estuarine dynamics progressively transition to a tidally dominated deltaic environment downstream of Milperra. Between East Hills and Picnic Point, the channel morphology shifts from dominantly alluvial margins to intermittent bedrock-confined margins as the Hawkesbury Sandstone formation becomes increasingly exposed (*Plate 2* left image).

*Plate 2 Bedrock outcropping is common in the valley confined sections of the Fluvial Transition process zone in both the Georges River (left: Reach 400) and Woronora River (right: Reach 603).*

The Woronora River flows through a laterally confined valley bordered by steep forested slopes underlain by Hawkesbury Sandstone (*Plate 2* right image). Bedrock confinement dominates the channel margins, with limited and discontinuous floodplain development at minor tributary junctions. Downstream, floodplain continuity increases, although bedrock bluffs remain a prominent morphological feature. The estuary is considered geomorphically mature, with its accommodation space largely infilled by sediment. Given the dominance of sandstone geology, bed and bank sediments are primarily sandy with low fines content (*Plate*

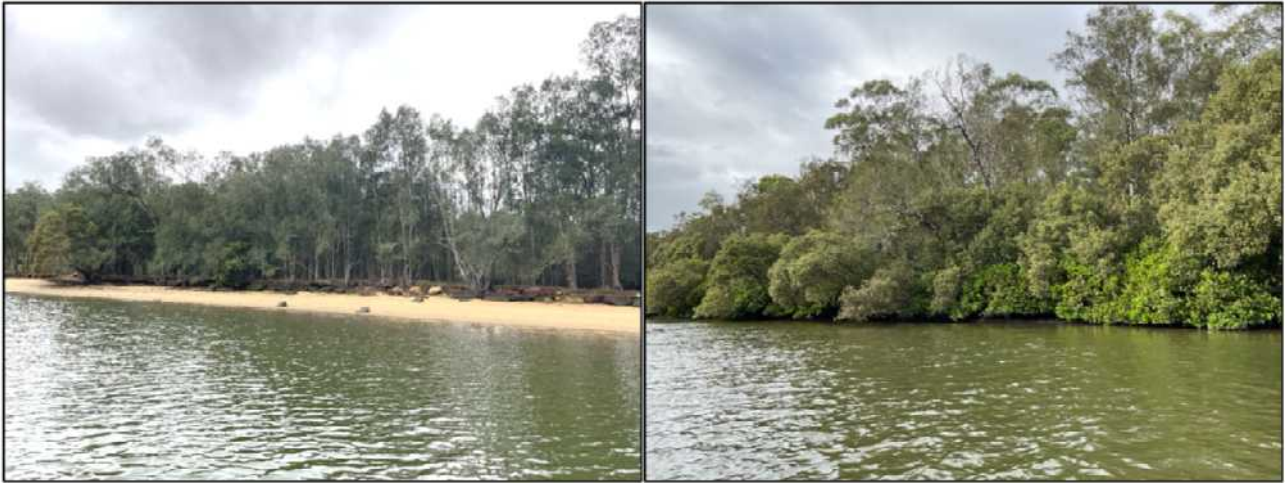
*Plate 3 Bed and bank material is predominantly fine sands in the Fluvial Transition process zone: for example Woronora River Reach 575; greater development of low alluvial floodplains has resulted in more extensive swamp oak floodplain forests, for example Reach 256 Georges River.*

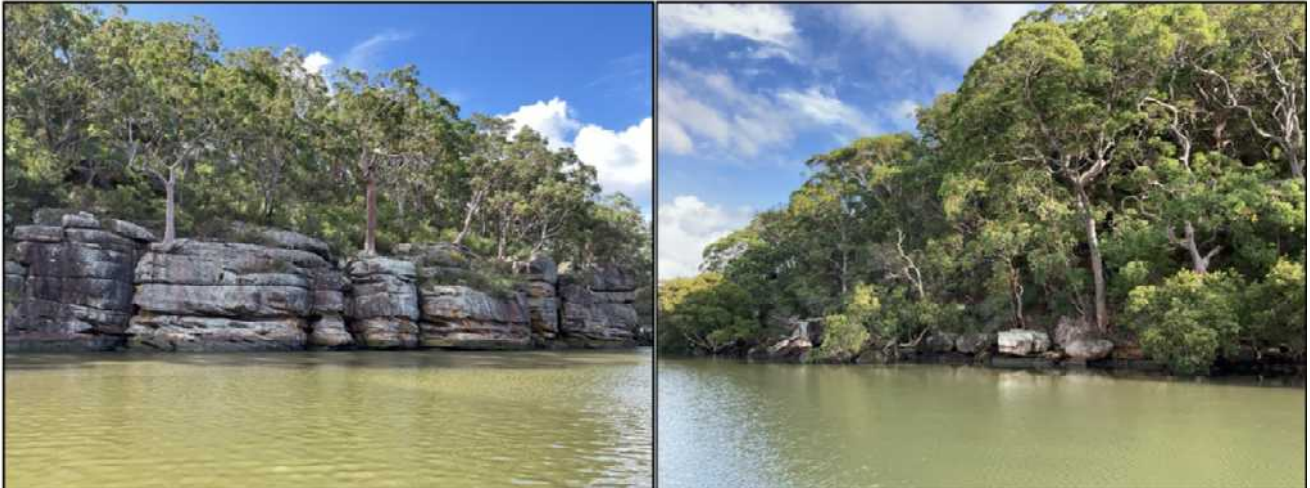
*Plate 4 Bedrock outcropping is common in the valley confined sections of the Fluvial Transition process zone in the Georges River: image left Reach 460 and image right Reach 723).*

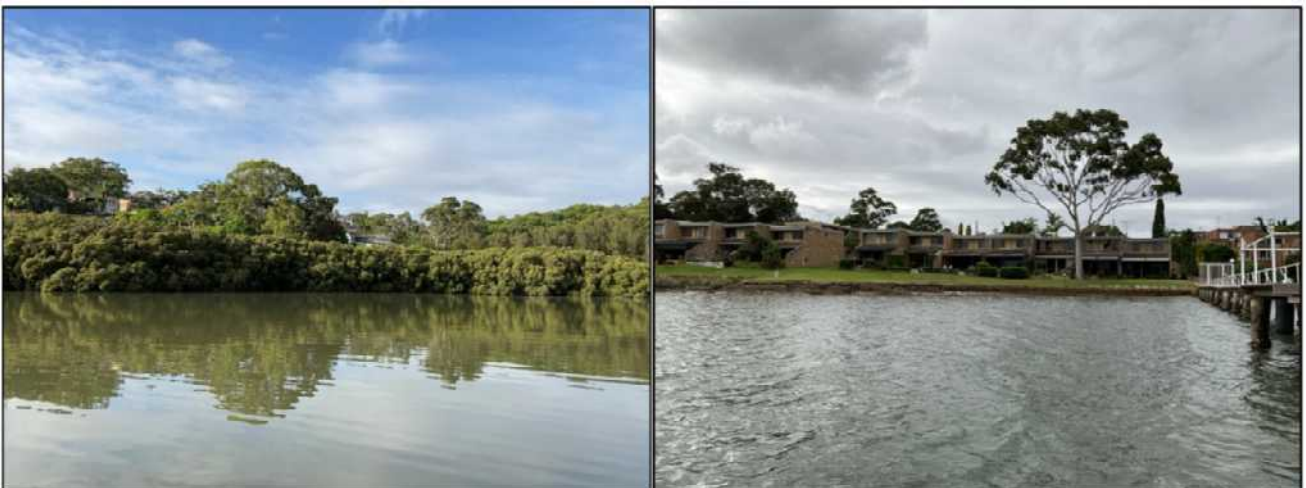
**Plate 5** Many of the embayments in the Mud Basin process zone have intact fringing mangrove communities at least in the upstream extents (left image: Oyster Bay Reach 948), however there are many areas where foreshore development and clearing has significantly degraded this important estuarine habitat (e.g. right image: Georges River Reach 979).

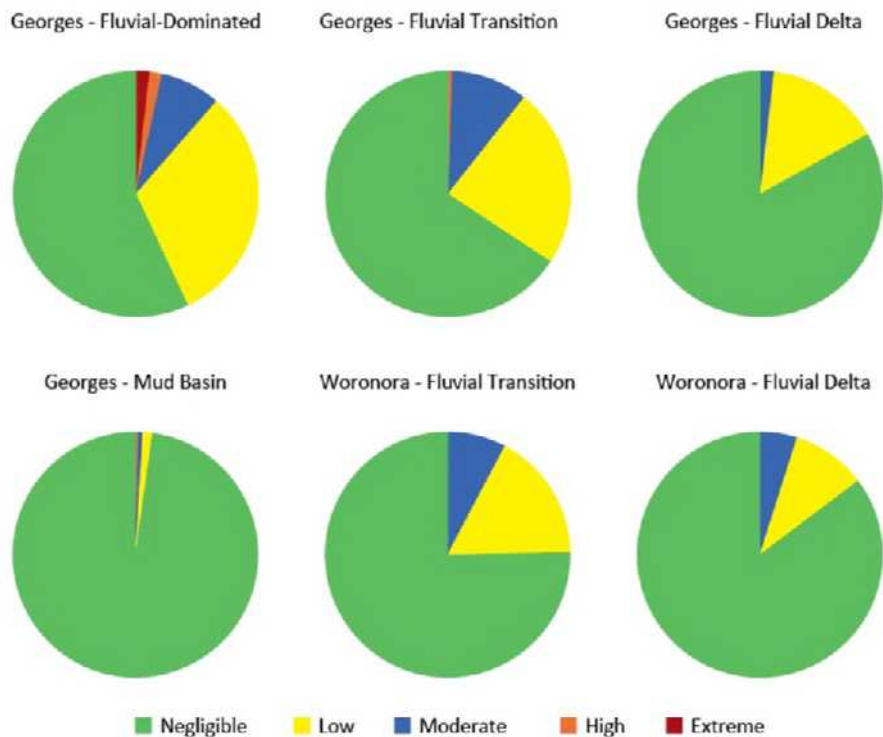
**Figure 16** Proportional distribution of bank erosion severity within each estuary of the Georges River study area.

Instances of High and Extreme erosion are primarily confined to the fluvial-dominated process zone of the upper Georges River estuary. These reaches are underlain by erodible alluvial bank materials and are more susceptible to fluvial erosion processes during high-flow or flood events. Extreme erosion was predominantly observed along outer channel bends, consistent with the fluvial dynamics of this zone. However, a notable reach of approximately 400 m at Milperra, which was in the early stages of remediation at the time of survey, exhibited Extreme erosion likely heavily impacted by boat wake rather than fluvial processes. Downstream, only isolated occurrences of High erosion were identified and there was no Extreme erosion. Specifically, one reach was identified within the fluvial transition zone (92 m) and one reach in the mud basin process zone (123 m). No High or Extreme erosion was recorded in the Woronora River or in the fluvial delta process zone.

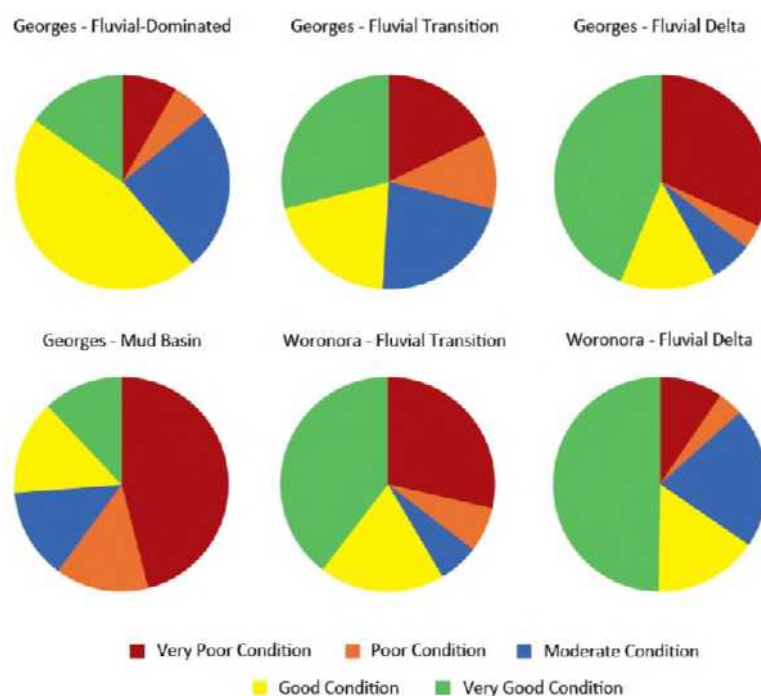
**Figure 18** Proportional distribution of riparian vegetation condition severity within each estuary of the Georges River study area.

Downstream in the Fluvial Transition zone, there is an increase in both Very Good and Very Poor vegetation condition, resulting in a relatively even distribution across all condition classes (*Table 10*). This pattern reflects the mix of residential development and parkland along the estuary foreshore. In developed areas, riparian vegetation has often been entirely removed, with foreshore protection structures replacing natural banks. Conversely, parklands and national parks contribute substantial areas of healthy vegetation communities. These include fringing mangroves, sandstone hillslopes with dry sclerophyll forest, and alluvial flats supporting swamp oak floodplain forest or saltmarsh.

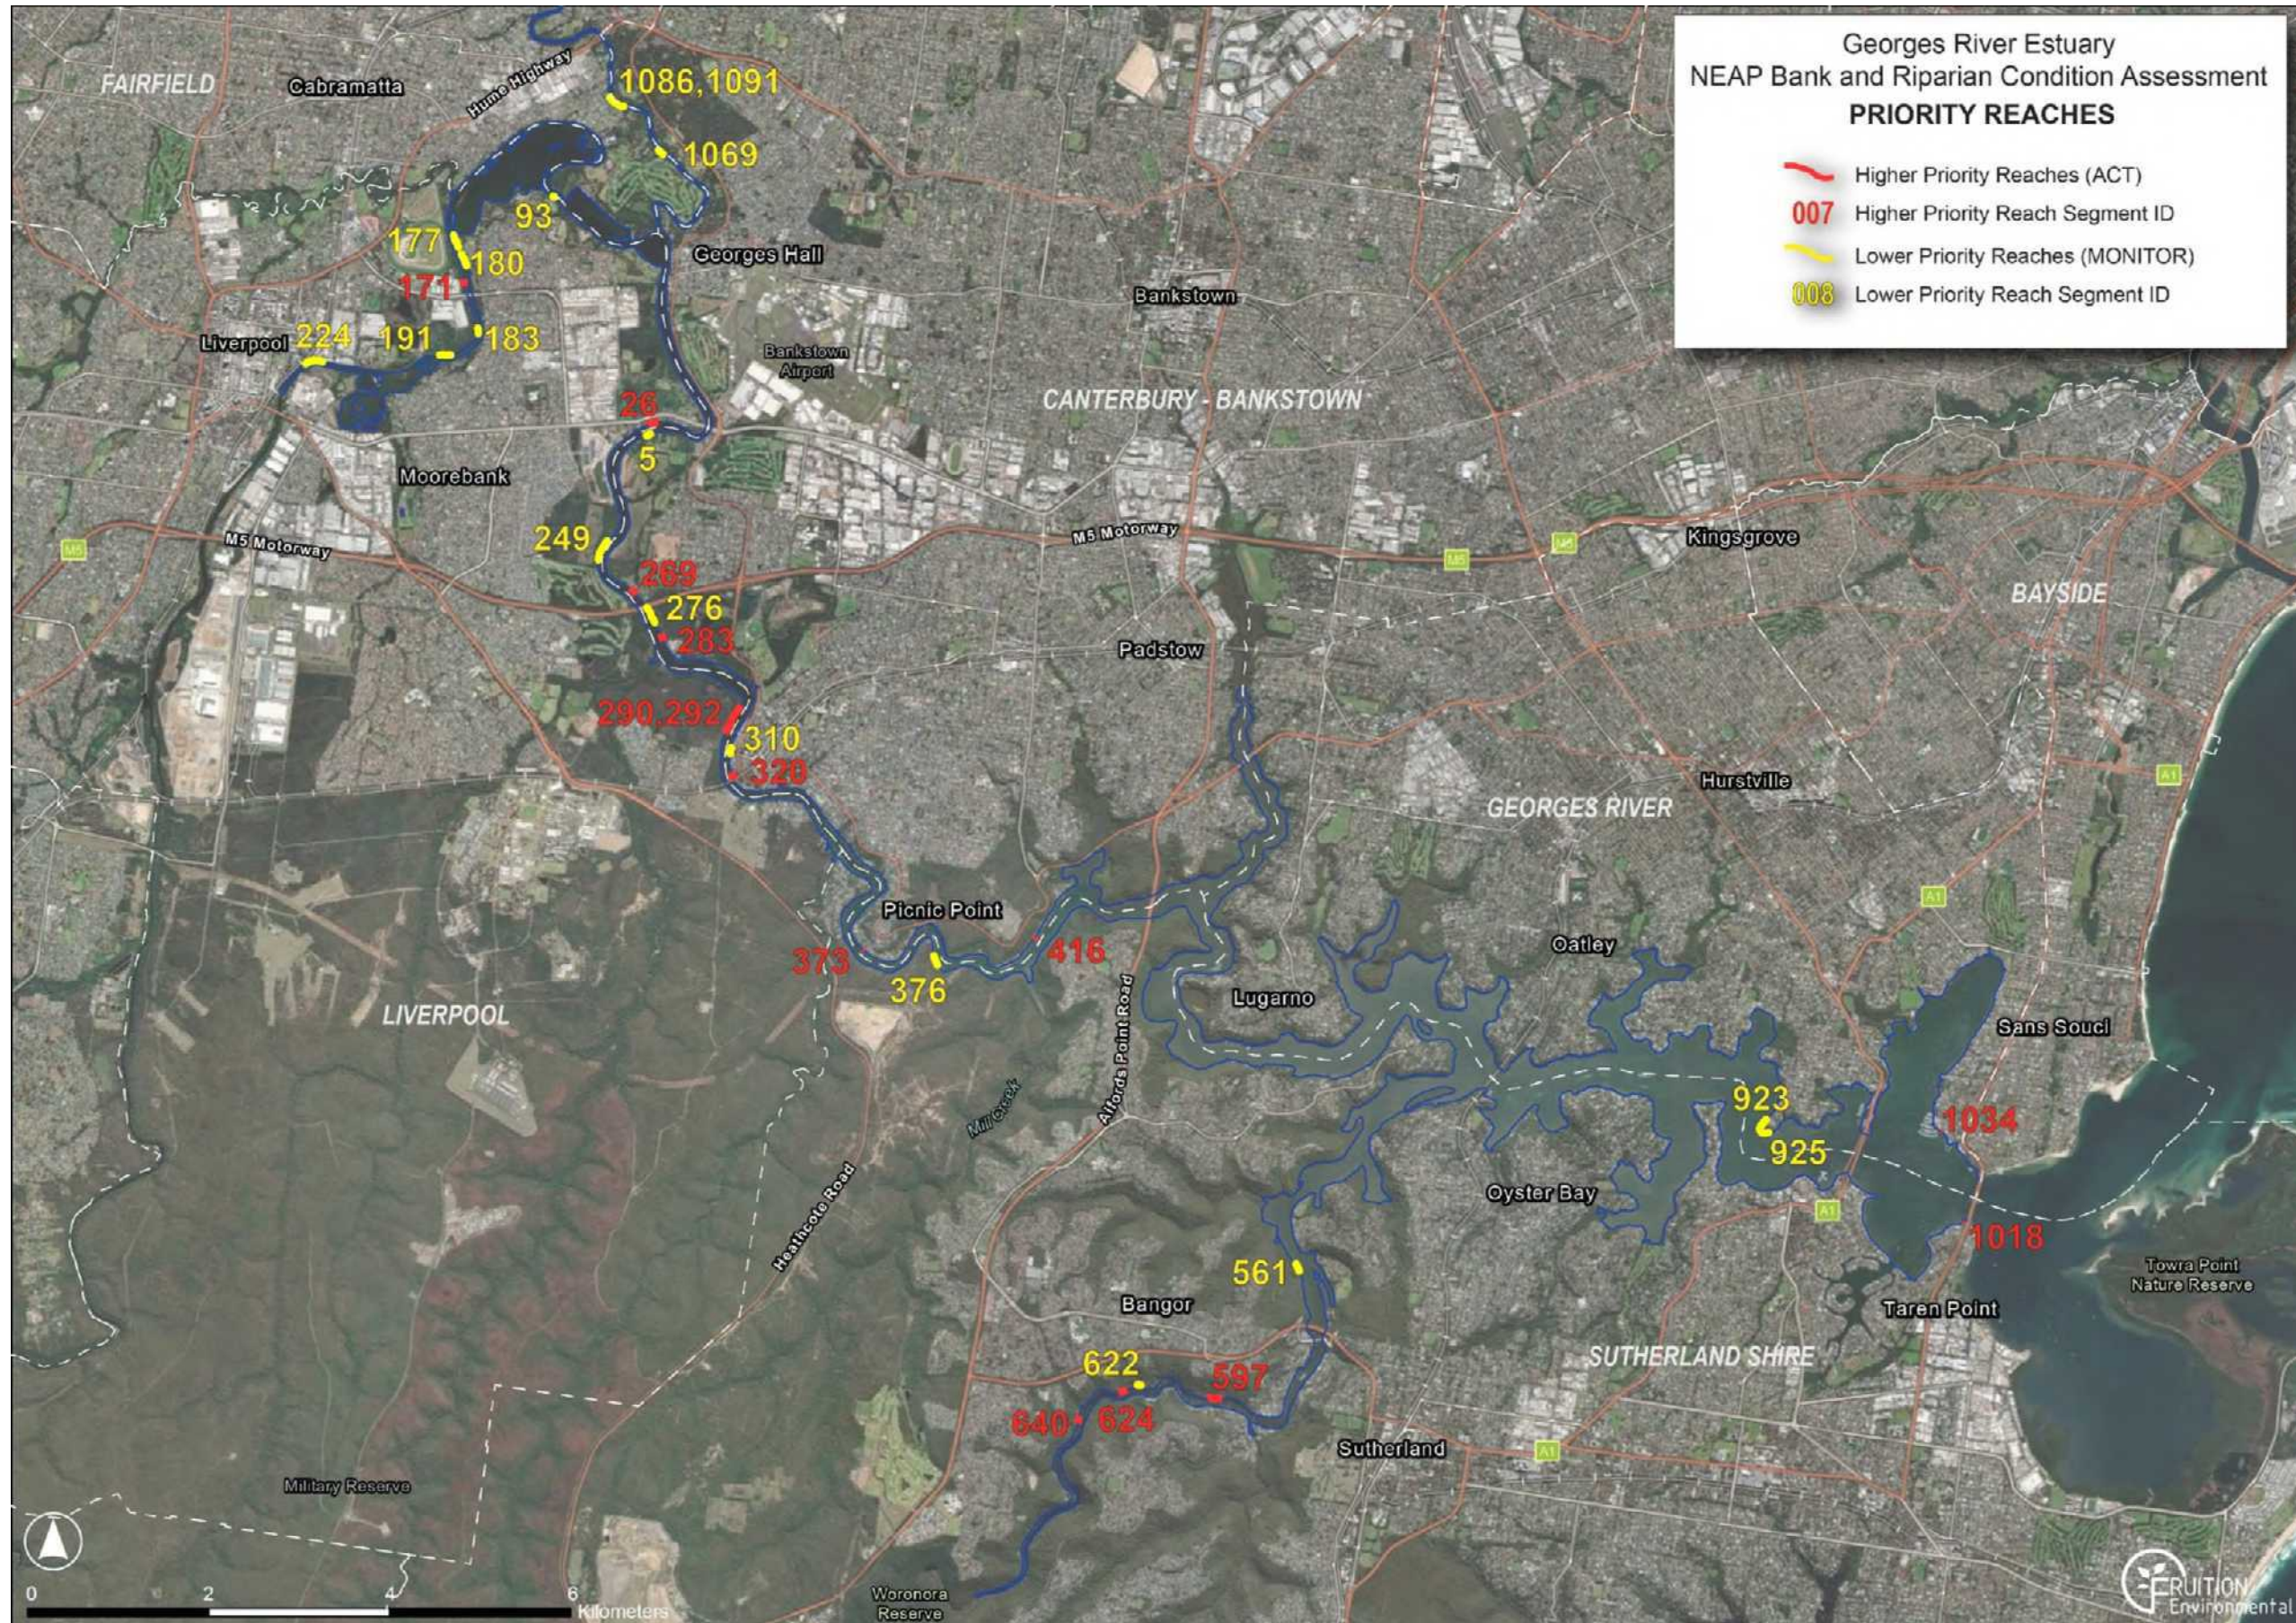
Figure 21 Locations and Reach reference IDs for priority reaches for management intervention in response to the Georges River Estuary NEAP Bank and Riparian Condition Assessment 2025.

*Table 17* lists the top 11 ranked reaches/focus areas within the Georges River estuary study area. The main issues identified as affecting the reach and the objectives of management intervention are listed. These locations are considered higher priority for management interventions to improve flood resilience, protect public assets and infrastructure, improve water quality, improve estuary health, and protect or enhance important riparian vegetation communities. The location of the higher priority reaches and focal areas are indicated in **red** in *Figure 21*.

For the Georges River Estuary NEAP Assessment, reaches not listed in *Tables 17–19* should be pro-actively monitored for any change, for example after flood events. These reaches are listed in *Appendix B* and their locations are indicated by yellow in *Figure 21*.
